Upper Rattlesnake Creek
Aquatic Habitat Enhancement Project
Elk Mountain Ranch
Carbon County, WY

FIN-UP Habitat Consultants, Inc.

Upper Rattlesnake Creek
Habitat Enhancement Project
Elk Mountain Ranch
Carbon County, WY

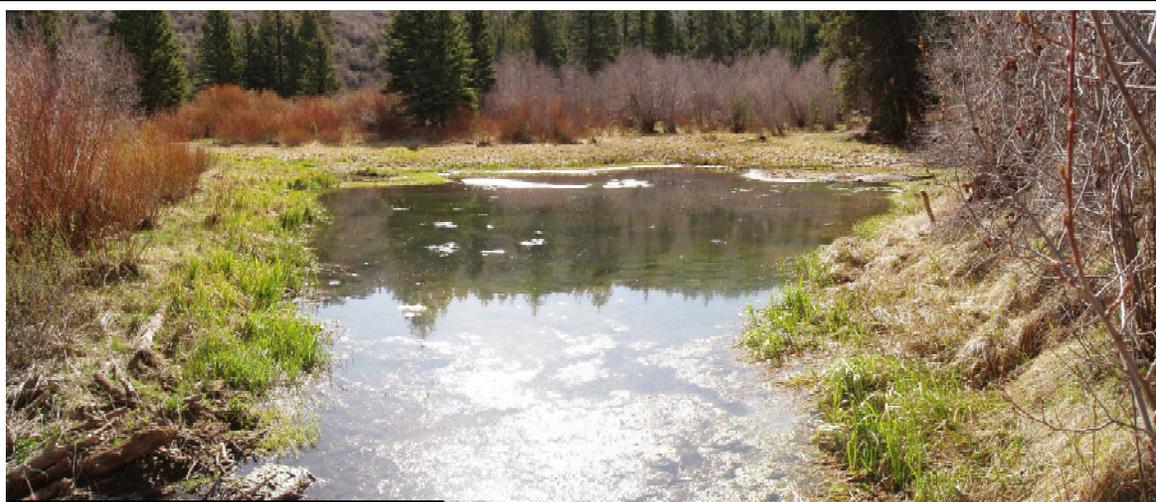
The off-channel beaver pond between the road and the stream in Reach 6 was identified in the 2006 Rapid Landscape Assessment as a critical feature in the watershed, and the ranch has expressed a keen interest in enhancing this feature and stocking it with trout. In May 2007, FIN-UP, Inc. collected data on the bathymetric profile of the pond, and mapped the pond's outlet and feeder streams, and the source of water feeding the pond.

Off-Channel Beaver Pond looking South East adjacent to Reach 6 on Rattlesnake Creek.

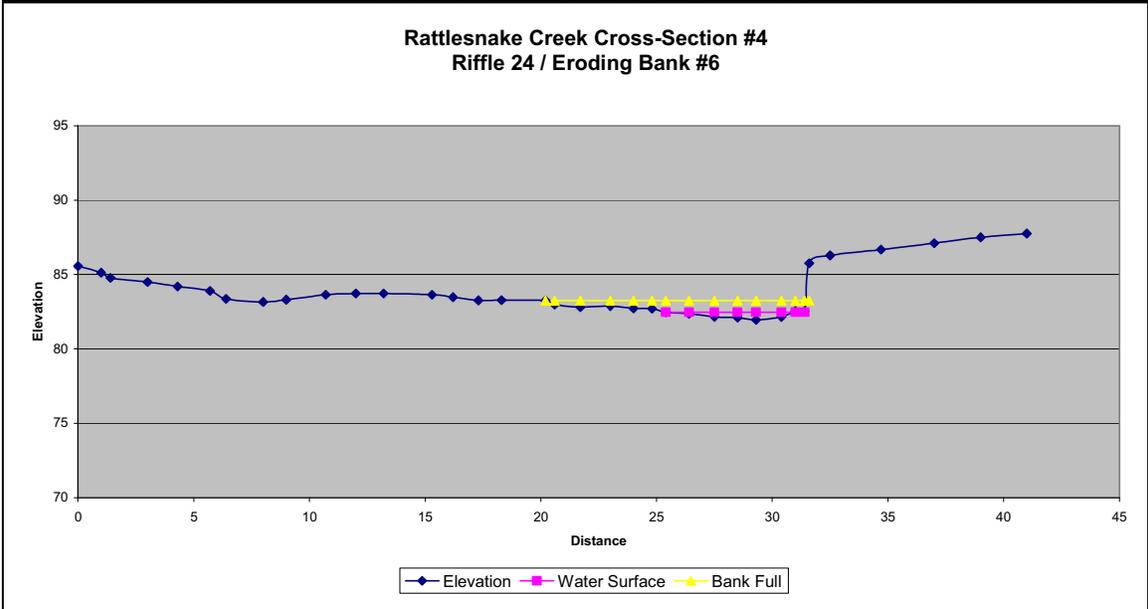
Chart 6: Cross-Section #4 @ R5-EB6 along Reach 5 on Rattlesnake Creek.

The other channel cross-sections indicate that there may be some lateral instability of the reach, with frequent vertical, poorly vegetated stream banks subject to considerable shear stress on the outside of the meander bends (Cross Sections #4 and #6). Cross-Section #4 (Chart 6) is a good example of lateral instability and bank failure occurring in the reach. The stream, though this cross-section, exhibits a tight meander bend, and is rapidly eroding the right bank, which is failing at several points. The width/depth ratio of the channel is currently 15.8 and appears to be gradually increasing. The point bar on the inside of the meander is stable however, and is well vegetated. The vegetation on the right bank however, consists of mostly shallow rooted upland grasses. Left untreated, the stream will continue to erode into the right bank, increasing sedimentation downstream. The photo in the chart above shows the cross-section from upstream, looking downstream at the site.

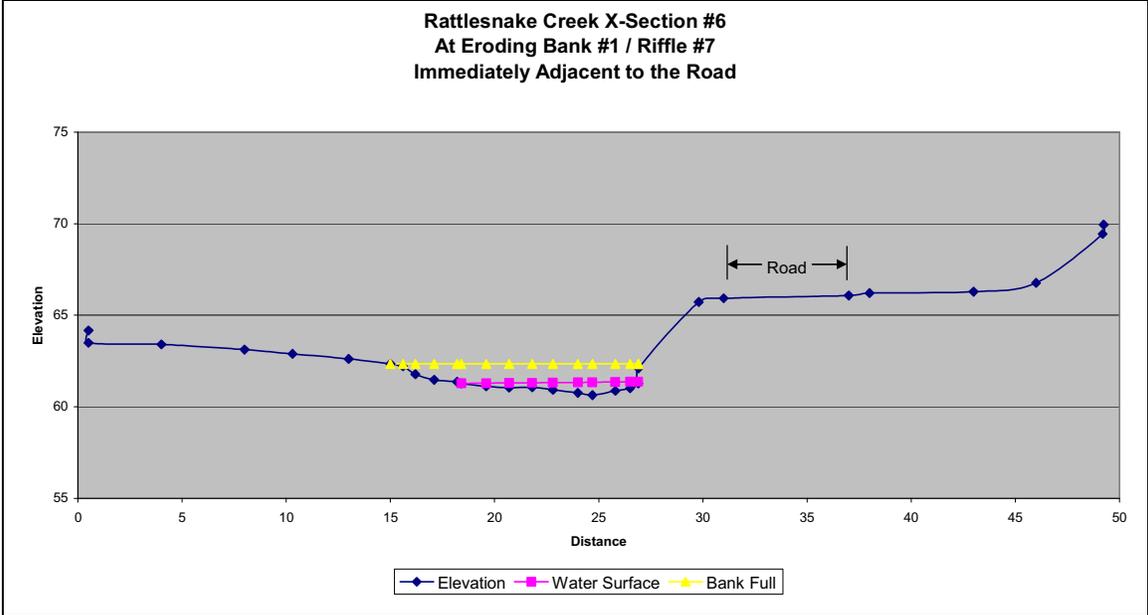
Chart 7: Cross-Section #6 @ R5-EB1 along Reach 5 on Rattlesnake Creek.

Cross-Section #6 is an example of the road/stream interactions occurring within the reach (Chart 7). As is the case with Cross-Section #4, the stream exhibits an extremely tight meander bend at the point where it is immediately adjacent to the road. The road-side stream bank vegetation is shallow rooted and very sparse, and the bank has failed at several points. Left untreated, the stream will eventually erode the bank to the point where the road will be cut-off. The photo in Chart 7 shows the cross-section from upstream of the site, looking downstream.

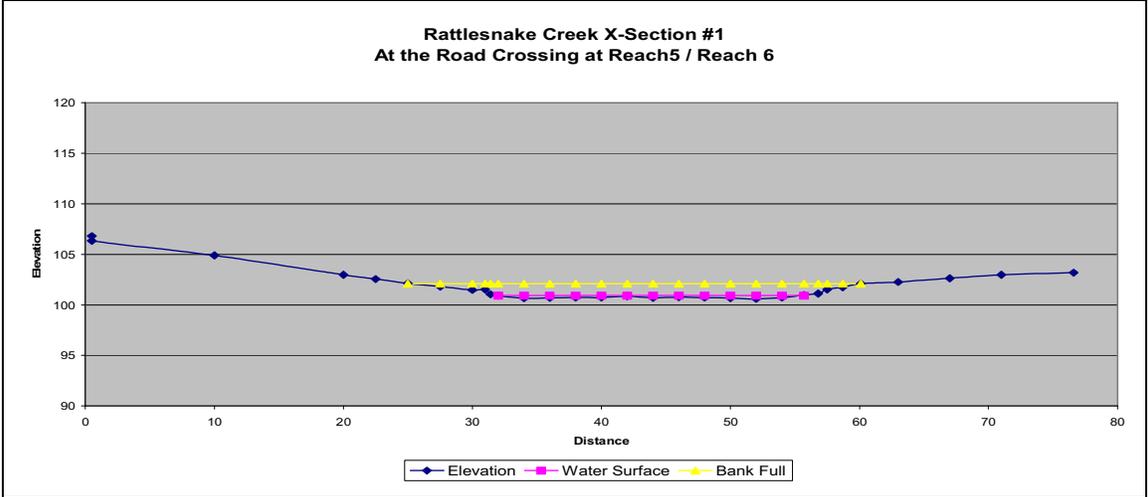
Chart 8: Cross-Section #1 @ the R5/R6 Reach Boundary on Rattlesnake Creek.

Additionally, there are several segments of the reach that exhibit channel width/depth ratios greater than would be expected or desirable in this channel type. Over-wide channels are a significant problem at the Reach 5/Reach 6 road crossing, and immediately downstream of this point (Cross-Section #3, Chart 9), where width/depth ratios range from 13 to over 31. The road crossing (Cross-Section #1, Chart 8) is likely a barrier to fish migration through the reach during the low flows found in late summer and fall, due to lack of depth or defined channel through the crossing. The photographs in each of these charts are taken from downstream of the cross-sections, looking upstream.

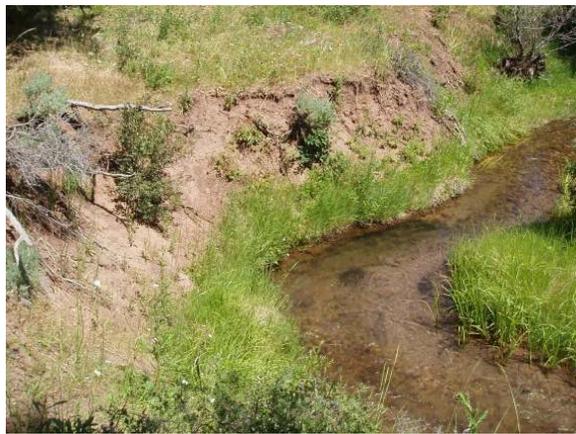
Photo 11 - Site R4-EB4 Downstream

The eroding bank at R4-EB4 is not easily accessible to equipment, and therefore will not be treated under this project. The unstable bank is approximately 70 ft long, and appears to be gradually healing, as evidenced by the line of riparian sedges that have become established along the toe-slope of

the stream bank (Photo 11). This bank should continue to be monitored to ensure that it continues this trend.

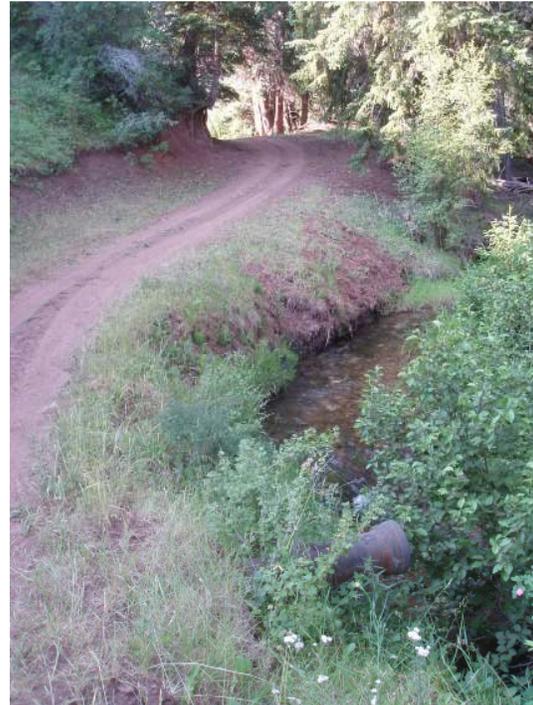
Photo 13 - Site R5-EB1 Looking U/S.

The first eroding stream bank treatment site on Reach 5 is designated as GPS point R5-EB1 on the map, and corresponds with Riffle 7 in the BWSHI and Cross-Section # 6 described in the previous chapter. The site consists of 35 ft. of actively eroding stream bank on the left side of the channel. The road is immediately adjacent to the stream channel at this site, and is at risk of collapsing into the stream (Photo 13). The road will need to be moved approximately 8 ft to the east, away from the stream. There is adequate width between the stream and the steep hill slope to allow for this re-location. The collapsing left bank will be stabilized using two log toe-slope bank structures placed flush against the existing stream bank. These toe-slope structures will be anchored using small boulder vanes extending 1/3 of the distance into the channel, at an angle not to exceed 30⁰ from the bank. These structures will further reduce the sheer stress along the outside of this meander bend, as well as providing additional in-stream cover within Riffle 7. The existing vertical bank will be sloped back to the edge of the newly relocated road and will be revegetated using native willow and sedges transplanted from the point bar on the inside of the meander bend. A total of 2 pieces of large wood, and 12 to 14 boulders (0.5 yd³ each) will be required for this site. Fill below the ordinary high water mark of the stream for the boulder vanes is estimated to be approximately 2.5 to 3.5 yd³ for each structure. Bank stabilization fill below the ordinary high water mark is expected to be approximately 0.1 yd³ per linear foot of bank for the log-toe-slope structures. Total fill for the site is estimated not to exceed 10 yd³.

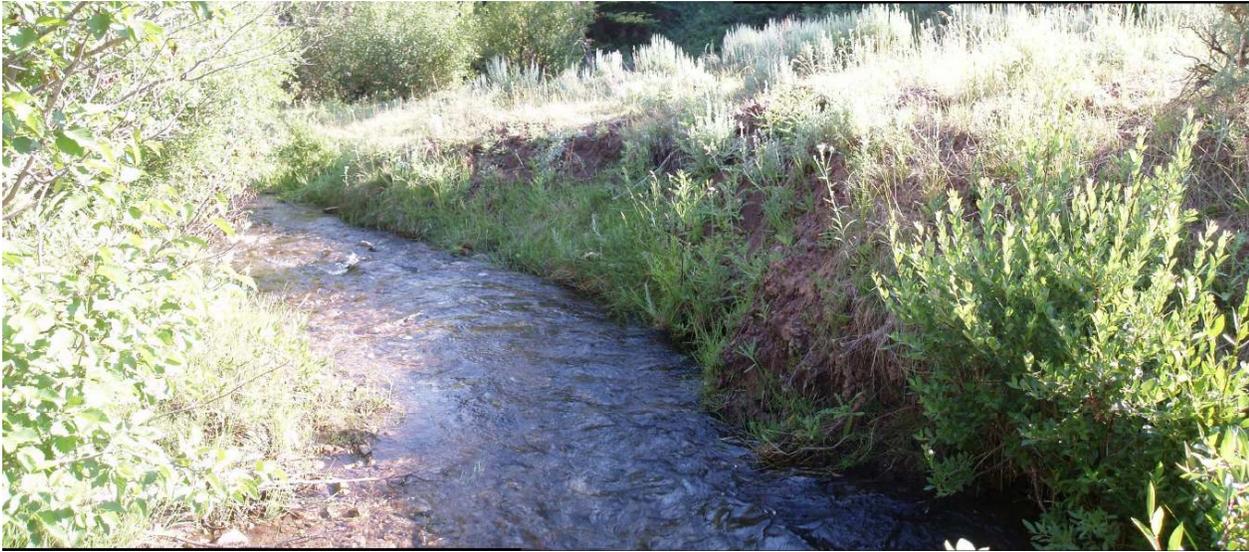
Photo 17 - Site R5-EB4 Looking Downstream at left bank.

Site R5-EB4 (Photo 17) corresponds with Riffle 21 in the BWSHI and consists of 120 ft of relatively unstable and steep stream bank on the left side of the channel, including 25 ft of actively eroding stream bank contributing sediment to the channel. Three logs will be installed flush with the left bank, and revegetated using native willow available on the other side of the stream. Additionally, two pools (Pool 21 and 22) will be enhanced by installing log/boulder vanes to improve scour and depth, as well as reducing sheer on the unstable left bank between the pools. Five pieces of large wood, and 8 boulders (0.5 yd³ each) will be required for this site. Fill below the ordinary high water mark of the stream for the log/boulder vanes is estimated to be approximately 2.5 to 3.5 yd³ per structure. Bank stabilization fill below the ordinary high water mark is expected to be approximately 0.1 yd³ per linear foot of bank for the log-toe-slope structure. Total fill for the site is estimated not to exceed 19 yd³.

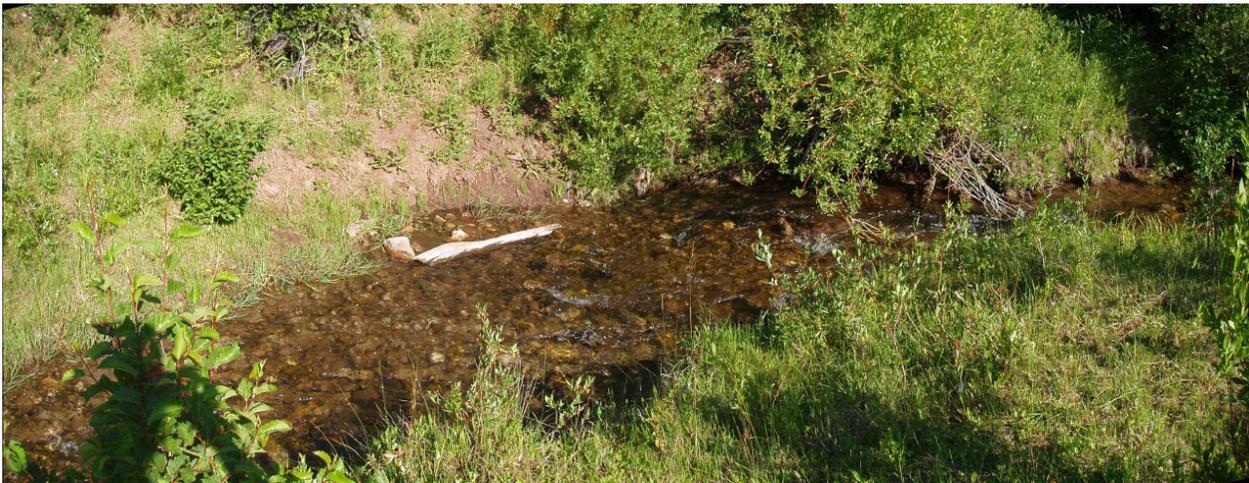
Photo 18 - Site R5-EB5 Looking Downstream at left bank.

Site R5-EB5 (Photos 18) corresponds with Pool 24 and Riffle 23 in the BWSHI and consists of 20 ft of actively eroding stream bank contributing sediment to the channel. Treatment will include installing a tree along the right stream bank, and revegetating the bank with willow harvested from the point bar on the inside of the meander bend. A small log/boulder vane will be installed at the downstream boundary of the toe slope structure to enhance scour and cover in Pool 24. Two pieces of large wood, and 4 - 5 boulders (0.5 yd³ each) will be required for this site. Fill below the ordinary high water mark of the stream for the log/boulder vane is estimated to be approximately 2.5 to 3.5 yd³. Bank stabilization fill below the ordinary high water mark is expected to be approximately 0.1 yd³ per linear foot of bank for the log-toe-slope structure. Total fill for the site is estimated not to exceed 5.5 yd³.

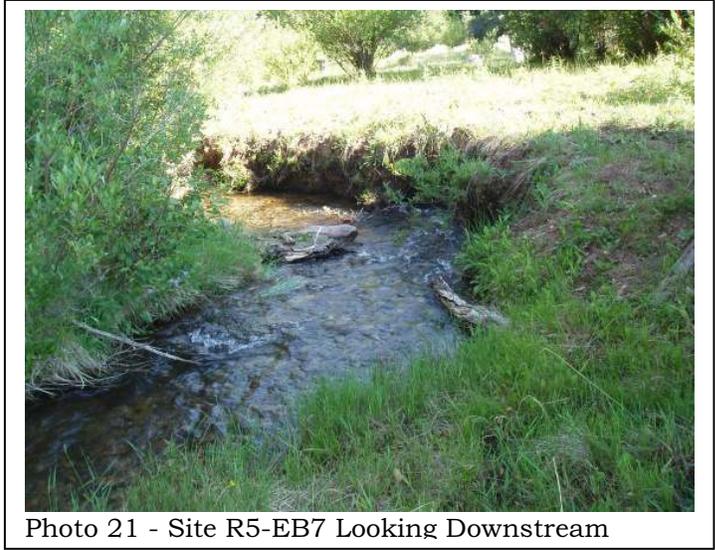
Photo 21 - Site R5-EB7 Looking Downstream

Site R5-EB7 (Photo 21) corresponds with Pool 26 in the BWSHI and consists of 17 ft of generally unstable stream bank on the left side of the channel. Treatment will include installing a tree flush along the left stream bank, and revegetating the bank with willow harvested from the point bar on the inside of the meander bend. A small log/boulder vane will be installed at the upstream boundary of the toe slope structure to enhance scour and cover in Pool 26. Two pieces of large wood, and 4 - 5 boulders (0.5 yd³ each) will be required for this site. Fill below the ordinary high water mark of the stream for the log/boulder vane is estimated to be approximately 2.5 to 3.5 yd³. Bank stabilization fill below the ordinary high water mark is expected to be approximately 0.1 yd³ per linear foot of bank for the log-toe-slope structure. Total fill for the site is estimated not to exceed 5.5 yd³.

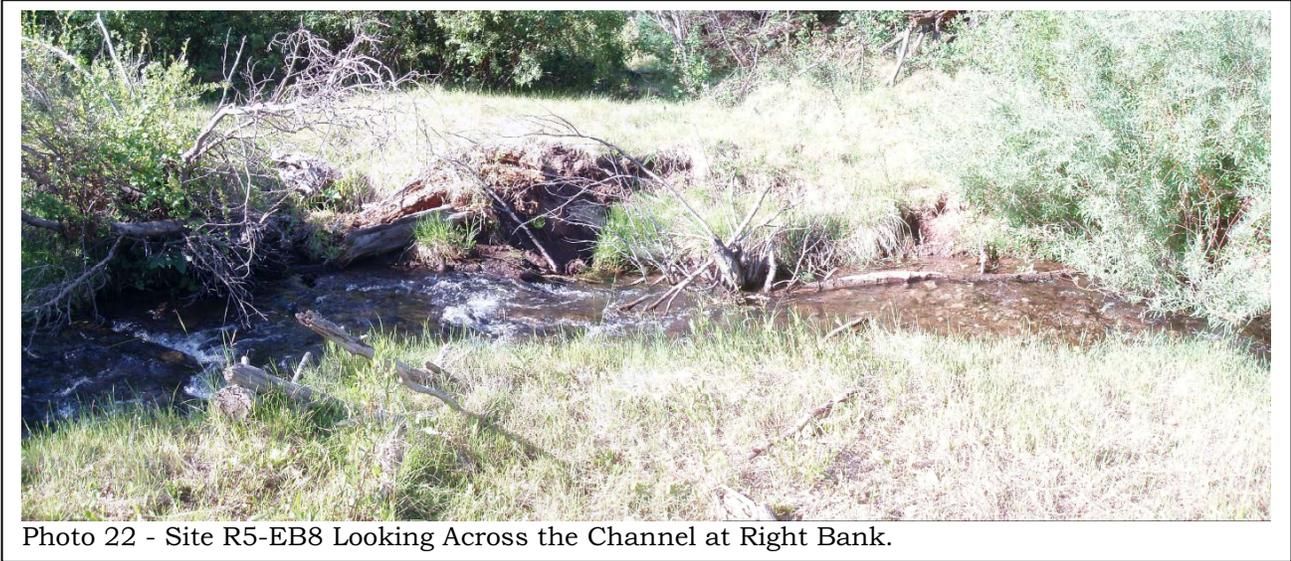
Photo 22 - Site R5-EB8 Looking Across the Channel at Right Bank.

Site R5-EB8 (Photo 22) corresponds with Pool 27 in the BWSHI and consists of 13 ft of generally unstable stream bank on the left side of the channel, with 7 linear feet of the bank actively contributing sediment to the system. Treatment will include installing a tree flush along the right stream bank, and revegetating the bank with willow and sedge harvested from near the site. A small log/boulder vane will be installed at the upstream boundary of the toe slope structure to enhance scour and cover in Pool 27. Additionally, some accumulated sediment will be excavated from the pool and removed from the site. Two pieces of large wood, and 4 - 5 boulders (0.5 yd³ each) will be required for this site. Fill below the ordinary high water mark of the stream for the log/boulder vane is estimated to be approximately 2.5 to 3.5 yd³. Bank stabilization fill below the ordinary high water mark is expected to be approximately 0.1 yd³ per linear foot of bank for the log-toe-slope structure. Total fill for the site is estimated not to exceed 5.5 yd³.

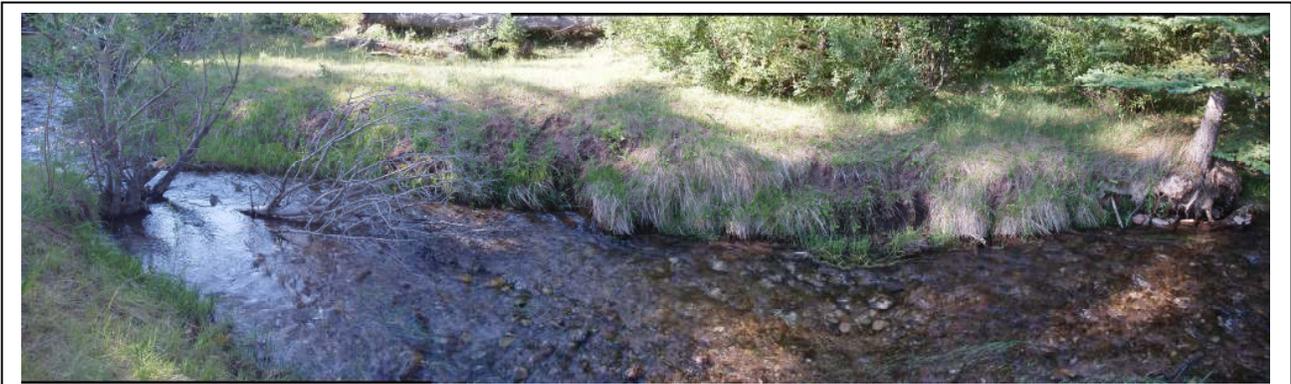
Photo 23 - Site R5-EB9 Looking Across the Channel at the Right Bank.

Site R5-EB9 (Photo 23) corresponds with Riffle 28 and Pool29 in the BWSHI and is characterized by unstable and poorly vegetated stream banks on the right stream bank. The site is approximately 30ft long. Treatments will include installing a tree flush along thirty feet of the right stream bank, and revegetating the bank with willow and sedge harvested from near the site. A small log/boulder vane will be installed at the tail of Pool 28 in order to increase residual pool depth and cover within this feature. Two pieces of large wood, and 5 - 6 boulders (0.5 yd³ each) will be required for this site. Fill below the ordinary high water mark of the stream for the log/boulder vane is estimated to be approximately 2.5 to 3.5 yd³. Bank stabilization fill below the ordinary high water mark is expected to be approximately 0.1 yd³ per linear foot of bank for the log-toe-slope structure. Total fill for the site is estimated not to exceed 6 yd³.

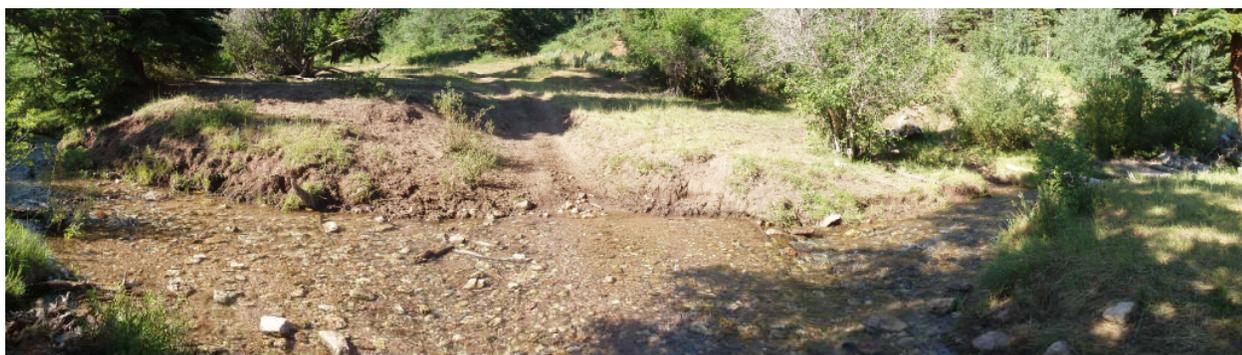
Photo 28 - Site R5-EB11/R6EB1 Looking Across the Channel at the Right Bank.

Site R5-EB11 and R6-EB1 (Photos 26, 27 and 28) correspond with the low water road crossing at the upstream Reach 5/Reach 6 boundary, and Cross-Sections #1 and #2 in the preceding chapter. R5-EB11 and R6-EB 1 are immediately adjacent, and have been combined into one project site for the purposes of this description. The channel throughout this site is characterized by high width/depth ratios, unstable and poorly vegetated stream banks, and severely limited habitat for trout. During low flows in the late summer and fall, the site is likely a barrier to migration of fall spawning brown trout. The site is approximately 100 ft long, with most of the banks actively contributing sediment to the channel. A schematic of the proposed work is shown in Diagram 1 and in the appendix.

Large wood toe-slope structures and transplanted willow will be utilized to define the stream banks throughout the site. These structures will be installed so as to reduce the width/depth ratio of the channel along Cross-Section to a W/D of 12 - 15 from the current W/D of 31. The areas behind these bank structures will be filled with transplanted willow and sedge mats harvested from areas nearby the site. A boulder cross vane will be installed immediately downstream of the low water crossing, in order to maintain the grade at the crossing, as well as to providing additional pool habitat and depth necessary for trout to maximize burst speed necessary to pass the low water crossing during low flows. Additionally, another cross vane will be installed at the upstream boundary of the site to create an additional new pool in Reach 6, as well as anchor the tree toe-slope treatments. This pool will provide additional velocity shelter and refugia for trout migrating upstream through the crossing during spawning. The road approaches to the low water crossing will be hardened using large gravel and cobble imported to the site. The gravel/cobble armoring of the approaches will extend down to the ordinary high water mark of the channel, but not below this elevation. Additionally, water-bars will be constructed on the southern approach to the crossing in order to deflect run-off from the road away from the creek. Benefits of this work will include eliminating the hydrologic connection between the road and the stream, eliminating a potential barrier to migration, and providing the ranch with a

potential hardened watering site for cattle when the pasture is grazed., Seven pieces of large wood, and 30 - 32 boulders (0.5 yd³ each) and approximately 22 yd³ of cobble will be required for this site. Fill below the ordinary high water mark of the stream for each cross-vane is estimated to be approximately 8 yd³. Bank stabilization fill below the ordinary high water mark is expected to be approximately 0.1 yd³ per linear foot of bank for the log-toe-slope structure. Additionally, up to 7 yd³ of transplanted willow and sedge mats may be used to re-vegetate the areas behind the log toe-slope structures. Total fill, including boulder, willow/sedge transplants and large wood for the site is estimated not to exceed 43 yd³.

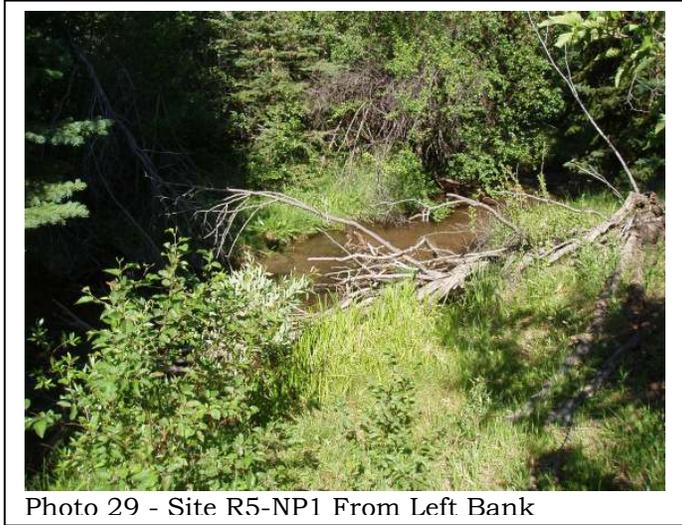
Photo 29 - Site R5-NP1 From Left Bank

The first new pool development site on Reach 5 is designated as GPS point R5-NP1 on the map, and corresponds with Riffle 5 in the BWSHI described in the previous chapter (Photo 29). The proposed work here is to install a log/boulder-vane above a brief low-gradient transition within the riffle habitat to create a new pool. One piece of large wood, and 3- 4 boulders (0.5 yd³ each)

will be required for this site. Fill below the ordinary high water mark of the stream for the log/boulder vane is estimated to be approximately 3 yd³. Larger cobbles/boulder armoring the channel within the pool may be removed to enhance scour. These materials will be placed outside the water influence zone of the stream.

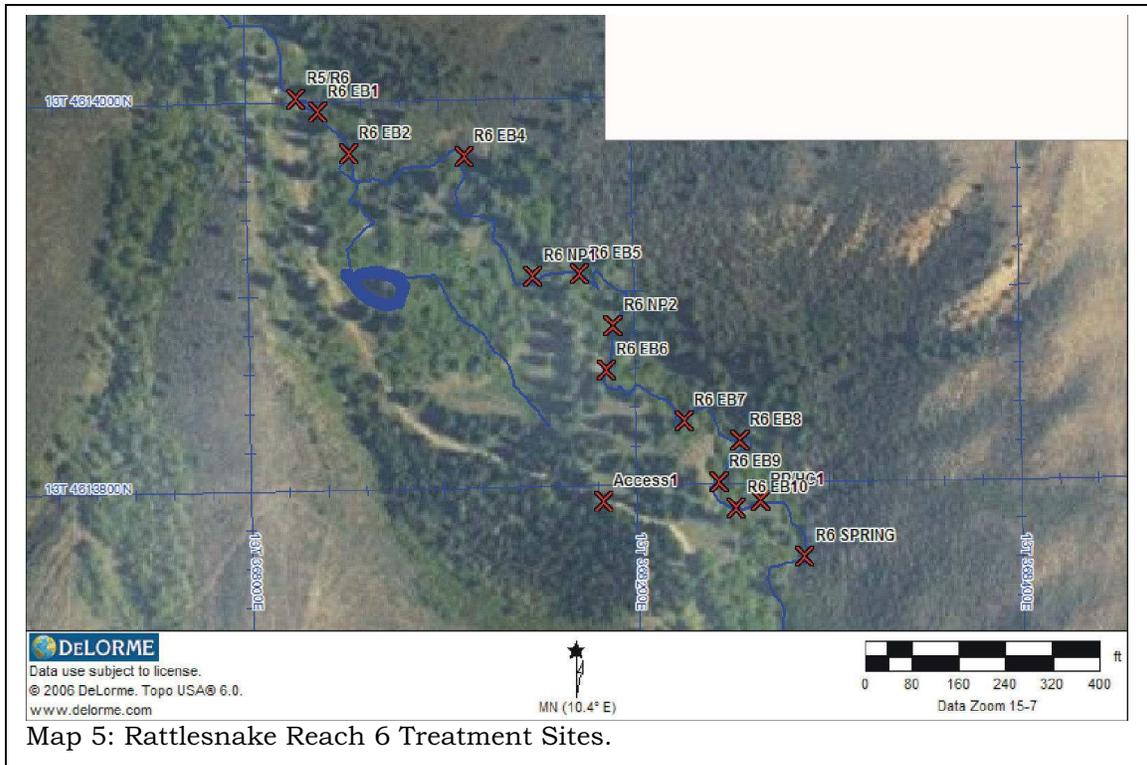
R6-EB1 has already been described as part of the low water road crossing work described in the previous section. R6-EB2 is located approximately 95 ft upstream, near the confluence of the off-channel beaver pond outflow channel

and Rattlesnake Creek (Photo 34). The site consists of 75 ft. of actively eroding stream bank on the right side of the channel, extending upstream past the confluence and up along the Beaver Pond outflow channel. The channel is over-wide throughout the upstream half of this site, due to the collapsing banks. There is good access to the site from the road immediately to the west. The collapsing right bank will be stabilized using three log toe-slope bank structures. The downstream log will be placed flush against the bank since W/D ratios are not an issue along this portion of the channel. The other two log toe-slope structures will be installed so as to reduce the width/depth ratio of the channel to a W/D of 10-11. Additionally, a cross vane will be installed at the downstream boundary of the site to enhance an existing pool, as well as anchor the tree toe-slope treatments. Three pieces of large wood, and 12 - 14 boulders (0.5 yd³ each) will be required for this site. Fill below the ordinary high water mark of the stream for the cross-vane is estimated to be approximately 6 yd³. Bank stabilization fill below the ordinary high water mark is expected to be approximately 0.1 - 0.25 yd³ per linear foot of bank for the log-toe-slope structure, depending on whether the structure is used to reduce W/D ratios in addition to bank stabilization and revegetation. Total fill for the site is estimated not to exceed 21 yd³.
