Aquatic Assessment
&
Habitat Enhancement Plan
Fountain Creek and Shryver Pond
Shryver Park
City of Manitou Springs
El Paso County - Colorado

FIN-UP Habitat Consultants, Inc.

J. Peter Gallagher
220 Illinois Ave
Manitou Springs, CO 80829
(719) 685-9768 (Office)
(719) 332-2550 (Cell)
pete@fin-up.com
June 1, 2008

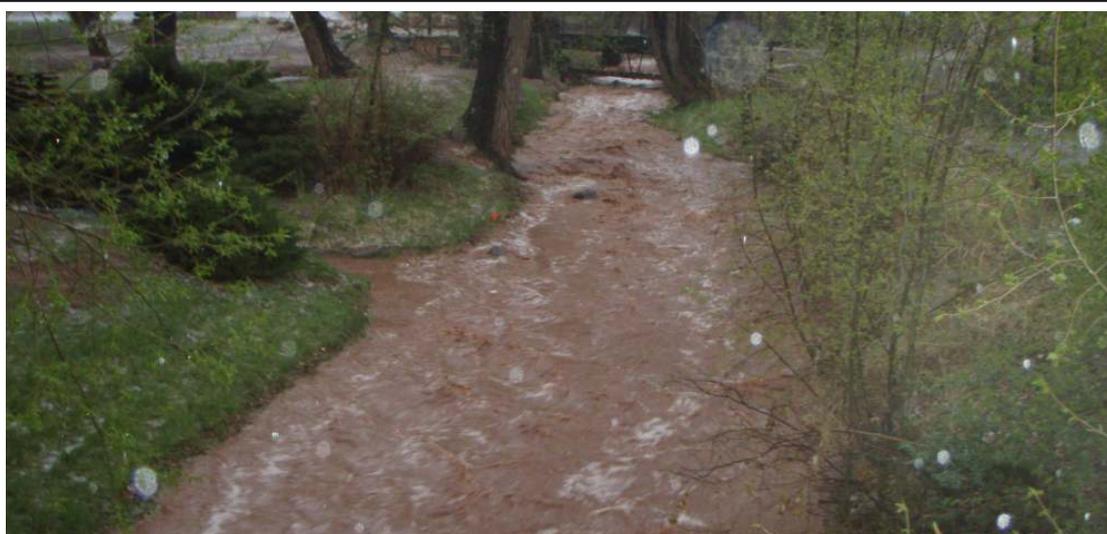
Photo 1: Fountain Creek near bank-full stage (75cfs) in the Project Reach.

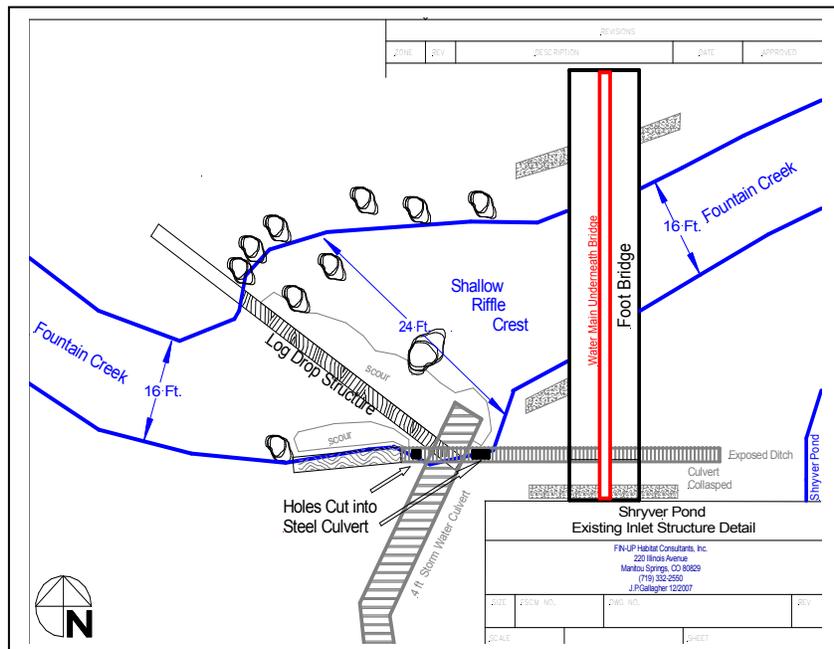
The diversion structure that feeds the pond is located on Fountain Creek immediately upstream and west of the pond. The intake culvert lacks a controlling head-gate, and is in significant disrepair. The downstream end of this culvert is approximately 0.4 ft higher than the upstream, intake end at the stream, causing frequent plugging of the pipe due to excessive sediment build up at the diversion point. This results in significantly reduced and sometimes completely restricted flows into the pond. Additionally, the log-drop structure at the intake represents a significant barrier to migration of resident brown and rainbow trout in Fountain Creek. A four foot diameter storm drain culvert has been installed directly over the pond inlet pipe, and is suspended approximately four feet over the stream channel, creating additional erosion problems along the bed of the channel downstream of the diversion point. A 12" water main is suspended underneath the foot bridge immediately below the project site. This high pressure water main crosses over the existing Shryver Pond inlet pipe underneath the south foundation of the bridge.

Shryver Pond is the only lentic habitat within the city limits, but in the current condition can not support a viable trout fishery. A complete redesign and reconstruction of the inlet structure is necessary to improve D.O. and temperature, particularly during the summer months, and restore the health of the pond. As part of reconstruction of the inlet structure, the drop structure barrier should be eliminated from Fountain Creek, and replaced by a series of boulder cross-vane structures, allowing for upstream migration and creating additional velocity shelter and cover for resident trout in the stream

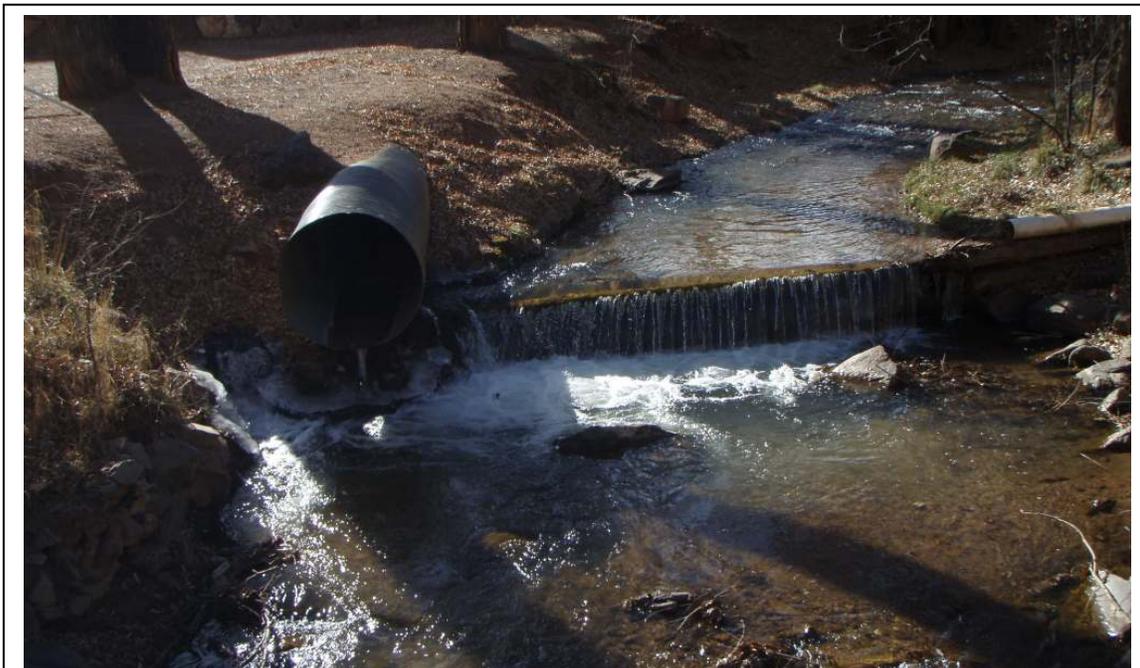
Photo 2: Diversion structure and potential fish barrier on Reach 4 - Shryver Park.

The first priority restoration effort includes reconstruction of the Shryver Pond Inlet works, including the elimination of the barrier to fish migration at the diversion point along Fountain Creek. The second priority will include bank stabilization and re-vegetation, as well as in-channel stream habitat enhancement within the remaining segments of Reach 4 in Shryver Park. The following section will address these priorities, and give specific recommendations and treatments to improve aquatic and riparian habitat conditions throughout the reach. A site plans showing the locations of the proposed enhancements can be found in the Appendix.

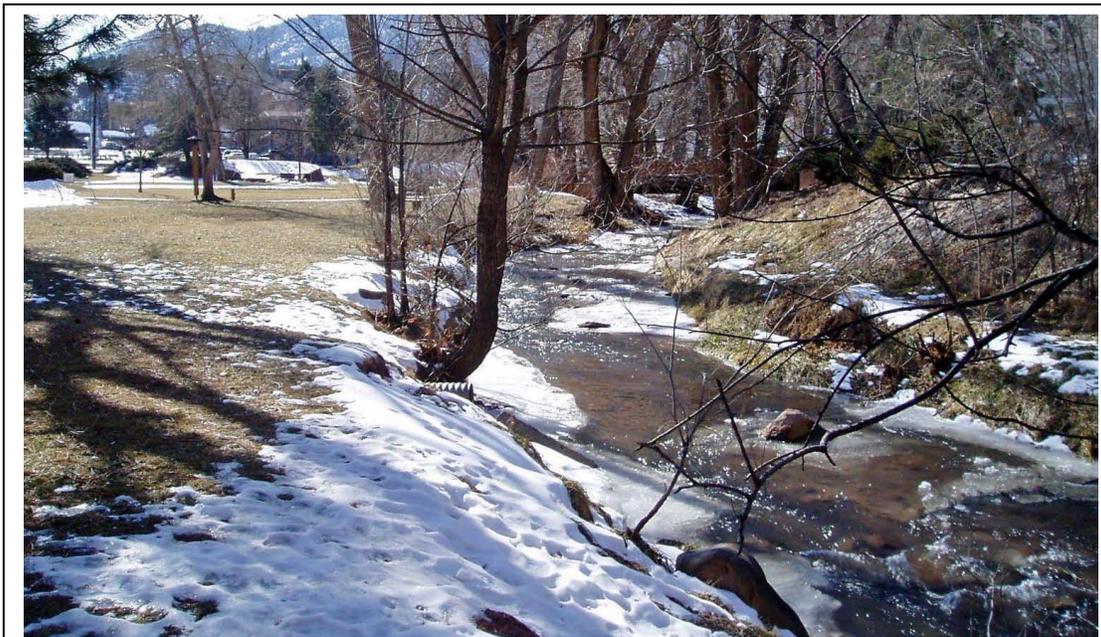
Photo 3: Lower half of the Shryver Park project reach, looking upstream.

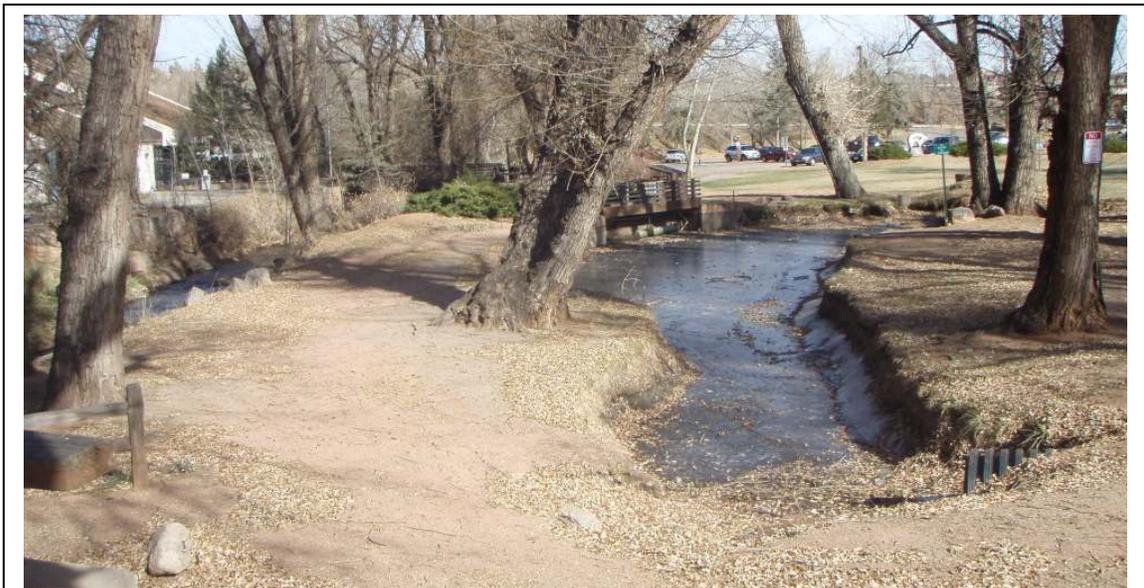
Photo 3: Middle of the Shryver Park project reach and Shryver Pond.

Stream bank stability was generally poor in the reach, primarily due to lack of vegetation on the steep collapsing stream banks. Several areas of actively eroding stream banks were observed, particularly in the upstream half of the reach. Deeply rooted, streamside riparian vegetation is a critical component in maintaining the integrity of stream banks during runoff and other high flow events, and was generally lacking in this reach. Fifty-three percent of the left bank and 42% of the right bank were found to be vegetated and stable. 5% of the left bank and 11% of the right banks were observed to be stable due to concrete toe walls that have been installed along the stream bank. The remaining 42% of the left bank and 47% of the right bank were found to be unstable. (Chart 9). Bank rock content in the reach is shown in Chart 10, and consisted either of concrete (Type 2), large boulder (Type 3) or gravel and smaller fragments (Type 6 and 8). Smaller fragments were the most dominant type, indicating that the stream banks are susceptible to erosion due to sheer forces occurring during high flows.
