Upper Rattlesnake Creek
Aquatic Habitat Enhancement Project
Elk Mountain Ranch
Carbon County, WY

FIN-UP Habitat Consultants, Inc.

Upper Rattlesnake Creek
Habitat Enhancement Project
Elk Mountain Ranch
Carbon County, WY

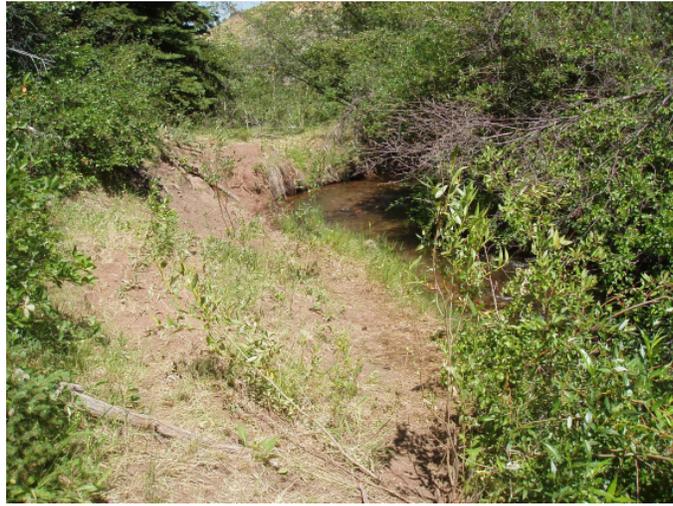
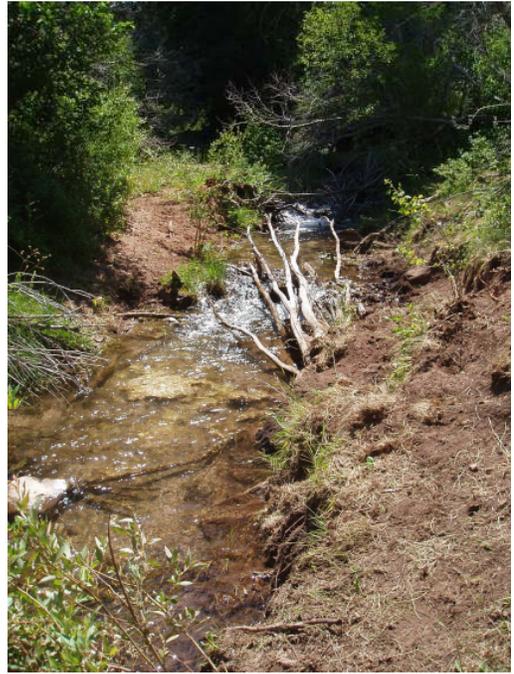
Photo 7 - Site R4-EB1 Downstream

The first treatment site on Reach 4 is designated as GPS point R4-EB1 on the map, and consists of 75 ft. of actively eroding stream bank on the right side of the channel. This segment of the stream lies along a corridor frequently utilized by elk, which has resulted in severe hoof-shear and collapse of the bank. Additional pressure from grazing cattle has resulted in banks that are nearly devoid of vegetation and actively contributing sediment to habitats downstream. Two pools exist along the 75 ft length, and could be further enhanced at the same time as the bank stabilization. The segment is shown in Photos 7 and 8, looking downstream and upstream respectively. Recommended treatment includes installing 3 log toe-slope structures along the right bank, and transplanting willow behind these structures. The channel throughout this segment is not overly wide, therefore the logs will be installed flush against the existing stream bank, creating a bench on which to transplant willow harvested from the riparian area beyond the left bank. A short segment of the right and left banks immediately downstream of Pool 3 will be armored with small cobble in order to provide a hardened crossing for elk. Two log/boulder J-hook vanes will be installed on the right bank adjacent to the existing pool habitats, to further protect the right bank and to enhance scour in these habitats. A total of 5 pieces of large wood, 8 to 10 boulders (0.5 yd³ each), and 1.5 yd³ of cobble will be required for this site. Fill below the ordinary high water mark of the stream for the log/boulder J-hook vane structures is estimated to be approximately 2.5 to 3.5 yd³ for each structure. Bank stabilization fill below the ordinary high water mark is expected to be approximately 0.1 yd³ per linear foot of bank for the log-toe-slope structures, and 0.2 yd³ per linear foot for the cobble hardened crossing. Total fill for the site is estimated not to exceed 15.5 yd³. Good access is available to the site along the elk / cattle path leading to the stream, therefore no wetlands will be effected in the course of this work.

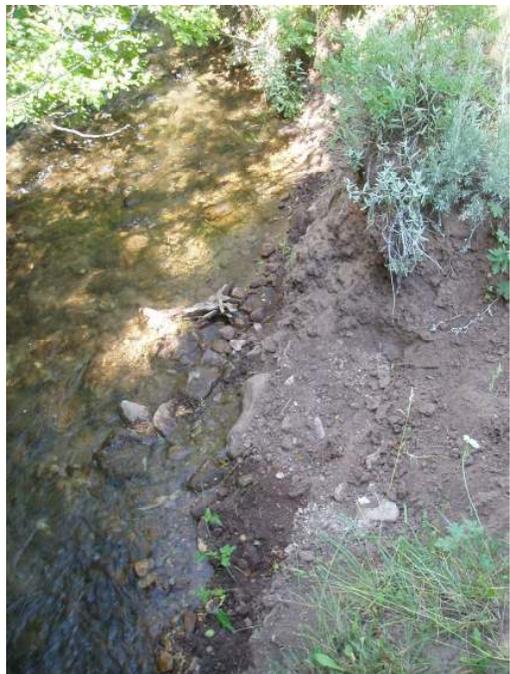
Photo 9 - Site R4-EB2 Left Bank

The next treatment site is designated as R4-EB2, and consists of a short segment of collapsing stream bank that can be easily treated with a single log toe-slope structure and willow transplant (Photo 9). The log will be installed flush with the existing bank, and anchored with two small boulders and willow transplants. Total fill below the ordinary high watermark of the stream channel should not exceed 0.2 yd³/linear foot of stream bank treated. Total fill is expected to be less than 3 yd³. The site is easily accessible from the Rattlesnake Creek road, and no wetlands will be affected.

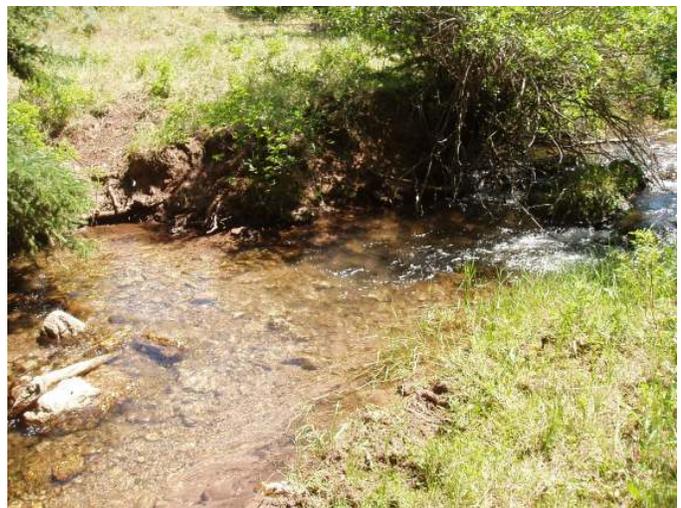
Photo 10 - Site R4-EB3 From Right Bank

Treatment site R4-EB3 is immediately adjacent to the Rattlesnake Creek road and consists of approximately 15 feet of eroding left bank with a very shallow pool near the upper end of the site (Photo 10). The eroding stream bank will be treated using a single log toe-slope structure (0.2 yd³/linear foot - 3 yd³ cumulative). The pool may be enhanced by removing some of the larger cobble and small boulders that are limiting scour in this feature. Any large rock removed from the pool will be used to anchor the ends of the log toe-slope structure on the left bank.

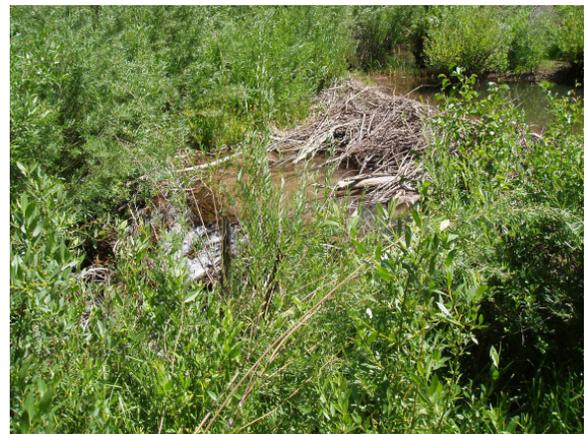
Photo 12 - Site R4-HC1 Looking Upstream

The small head-cut observed in Reach 4 is designated on the map as R4-HC1, and can barely be seen in Photo 12. This site is also inaccessible to equipment, therefore, the usual treatment of installing a grade controlling structure such as a cross vane will not be practical here. In lieu of a cross-vane, it may be desirable to create a woody debris dam pool immediately downstream of this feature by dropping two or three small tree-tops into the channel. The tree-tops will capture smaller woody debris moving through the stream and form a dam pool at the head-cut, reducing the downward erosional pressure on the channel. This work can be accomplished without the use of heavy equipment.

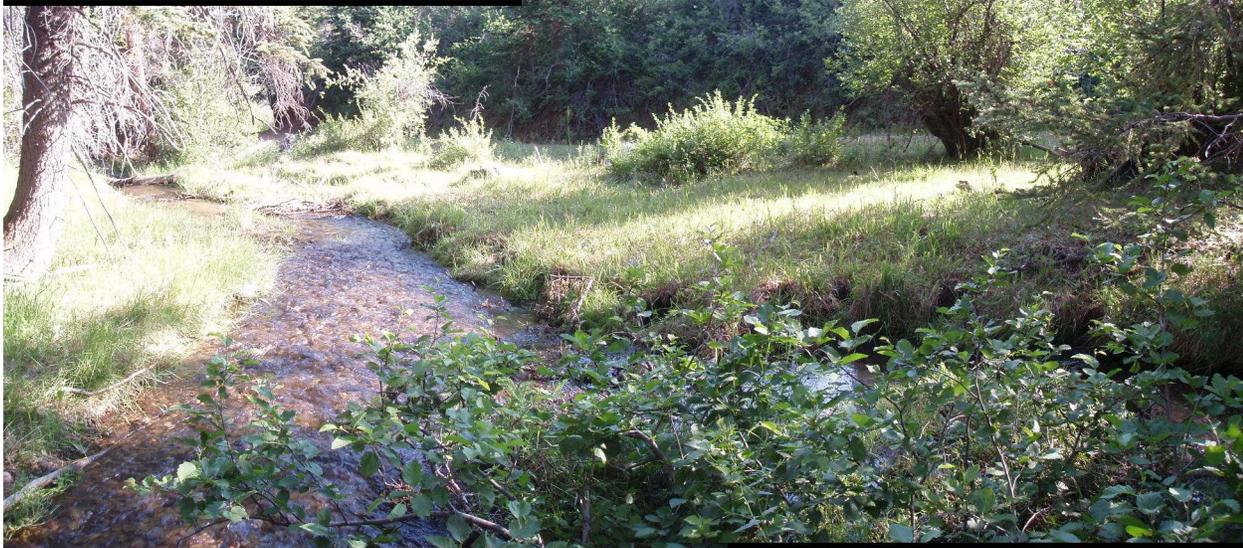
Photo 14 - Site R5-EB2 Looking Downstream

Treatment site R5-EB2 (Photo 14) corresponds with Riffle 10 in the BWSHI, and consists of 40 ft of unstable left stream bank, and a somewhat over-wide stream channel due to the formation of a mid-channel bar in the upstream boundary of the site. Treatments will include installing a large tree along the left stream bank, and revegetating the bank with sedges harvested from the mid-channel bar. A small log/boulder vane will be installed at the downstream boundary of this site to enhance scour and cover in Pool 8. Two pieces of large wood, and 4 - 5 boulders (0.5 yd³ each) will be required for this site. Fill below the ordinary high water mark of the stream for the log/boulder vane is estimated to be approximately 2.5 to 3.5 yd³. Bank stabilization fill below the ordinary high water mark is expected to be approximately 0.2 yd³ per linear foot of bank for the log-toe-slope structure. Total fill for the site is estimated not to exceed 10.5 yd³.

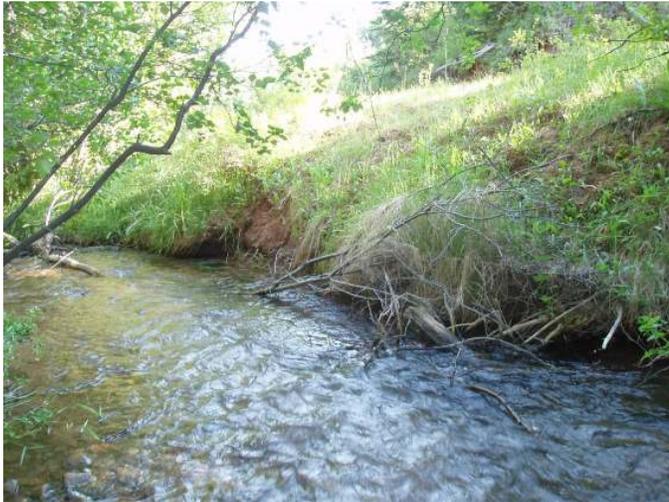
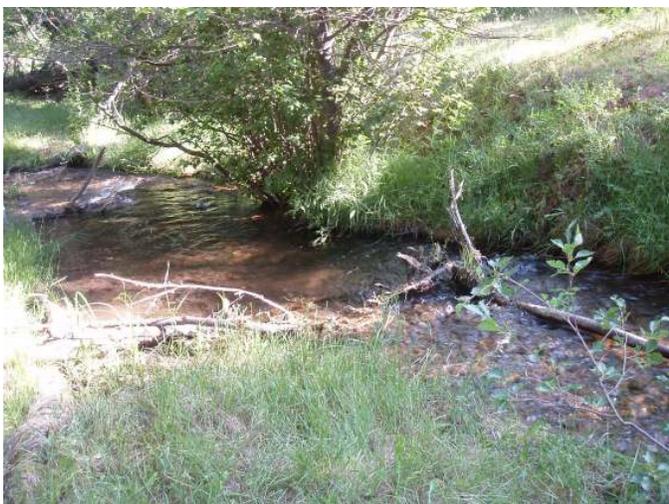
Photo 15 - Site R5-EB3 From the Right Bank

Site R5-EB3 (Photos 15 & 16) corresponds with Riffle 16 in the BWSHI and consists of 35 ft of actively eroding bank on the left side of the channel adjacent to the road. A log toe-slope structure will be installed flush with the left bank, and revegetated using native willow available on the other side of the stream. Additionally, a poorly developed pool (Pool 16) exists immediately below the actively eroding stream bank. This pool will be enhanced by installing a boulder cross vane to improve scour and depth of the pool, as well as anchoring the toe-slope structure above. One piece of large wood, and 13 -15 boulders (0.5 yd³ each) will be required for this site. Fill below the ordinary high water mark of the stream for the cross-vane is estimated to be approximately 7 yd³. Bank stabilization fill below the ordinary high water mark is expected to be

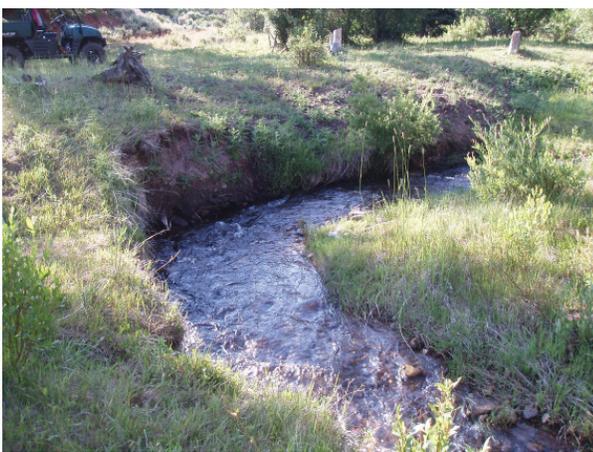
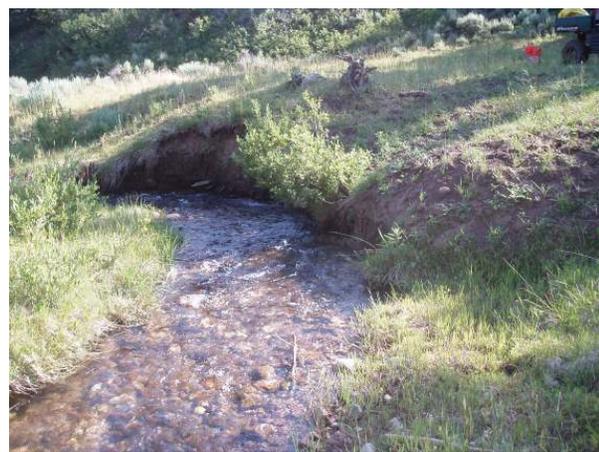
Photo 19 - Site R5-EB6 Looking Upstream

Site R5-EB6 corresponds with Riffle 24 in the BWSHI and Cross-Section # 4 described in the previous chapter. The site consists of 40 ft. of actively eroding stream bank on the left side of the tightly meandering stream channel (Photos 19 and 20). Enlarging the stream meander radius of curvature, lengthening the channel and reducing the water surface slope will reduce the sheer on this extremely unstable bank. The left bank of the stream will be excavated approximately 3 feet in order to increase the radius of curvature of the meander bend. Material from this excavation will be used to augment the point bar on the inside of the meander bend in order to maintain the existing channel width/depth ratio and cross-sectional bank-full dimension. The new stream bank will be stabilized using two log toe-slope bank structures placed flush against the bank, with the slope above pulled back to an angle of repose of 3:1 or less. These toe-slope structures will be anchored on the downstream side and middle of the bank by installing two small boulder vanes extending 1/3 of the distance into the channel, at an angle not to exceed 30° from the bank. A full channel cross-vane will be installed at the upstream boundary of the site to anchor the toe slope treatments, as well as creating additional pool habitat. The left stream bank and augmented point bar will be re-vegetated using native willow and sedges transplanted from behind the point bar on the inside of the

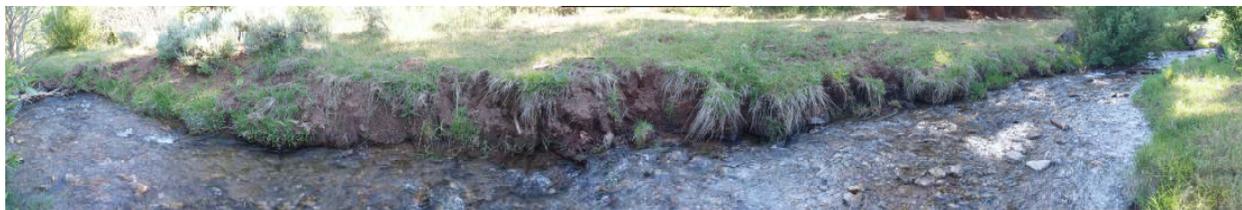
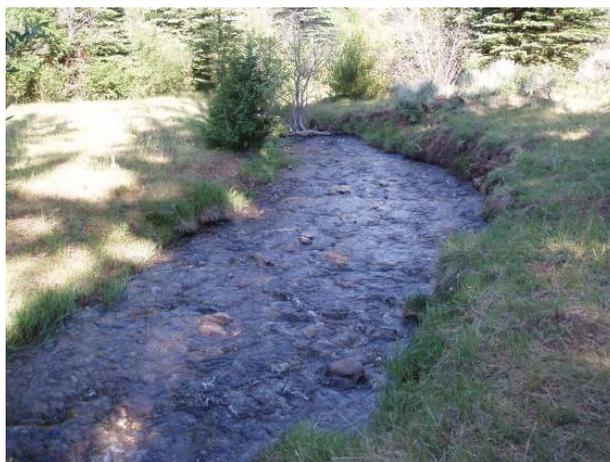
Photo 25 - Site R5-EB10 Looking Downstream

Site R5-EB10 (Photos 24 & 25) corresponds with Riffle 29 in the BWSHI and Cross-Section #3 in the preceding chapter. The channel throughout this site is characterized by high width/depth ratios, unstable and poorly vegetated stream banks, and generally limited habitat for trout. The site is approximately 66 ft long, with 45 ft of eroding banks actively contributing sediment to the channel. Forty-five feet of unstable bank on the left side of the channel will be stabilized using large wood toe-slope structures and transplanted willow. These structures will be installed so as to reduce the width/depth ratio of the channel along Cross-Section to a W/D of 10 from the current W/D of 13. Additionally, a cross vane will be installed at the upstream boundary of the site to create a new pool, as well as anchor the tree toe-slope treatments. Two pieces of large wood, and 14 -16 boulders (0.5 yd³ each) will be required for this site. Fill below the ordinary high water mark of the stream for the cross-vane is estimated to be approximately 7 yd³. Bank stabilization fill below the ordinary high water mark is expected to be approximately 0.25 yd³ per linear foot of bank for the log-toe-slope structure. Total fill for the site is estimated not to exceed 17 yd³.

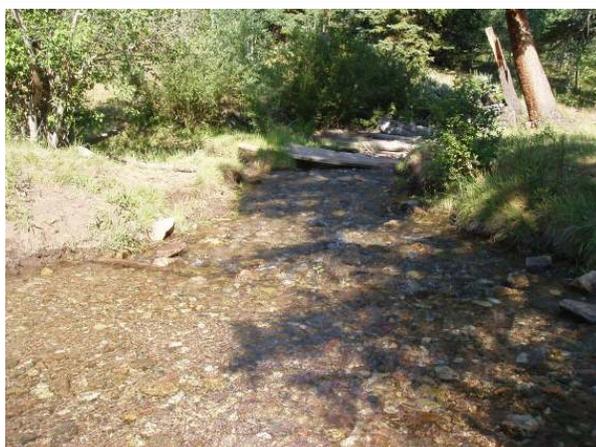
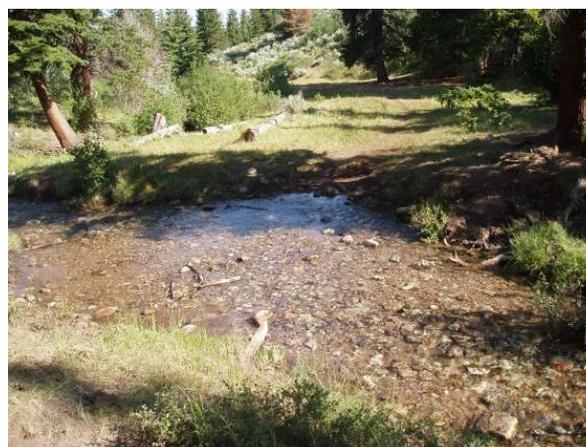
Photo 26 - Site R5-EB11 Looking D/S.

Site R5-EB11 and R6-EB1 (Photos 26, 27 and 28) correspond with the low water road crossing at the upstream Reach 5/Reach 6 boundary, and Cross-Sections #1 and #2 in the preceding chapter. R5-EB11 and R6-EB 1 are immediately adjacent, and have been combined into one project site for the purposes of this description. The channel throughout this site is characterized by high width/depth ratios, unstable and poorly vegetated stream banks, and severely limited habitat for trout. During low flows in the late summer and fall, the site is likely a barrier to migration of fall spawning brown trout. The site is approximately 100 ft long, with most of the banks actively contributing sediment to the channel. A schematic of the proposed work is shown in Diagram 1 and in the appendix.

Large wood toe-slope structures and transplanted willow will be utilized to define the stream banks throughout the site. These structures will be installed so as to reduce the width/depth ratio of the channel along Cross-Section to a W/D of 12 - 15 from the current W/D of 31. The areas behind these bank structures will be filled with transplanted willow and sedge mats harvested from areas nearby the site. A boulder cross vane will be installed immediately downstream of the low water crossing, in order to maintain the grade at the crossing, as well as to providing additional pool habitat and depth necessary for trout to maximize burst speed necessary to pass the low water crossing during low flows. Additionally, another cross vane will be installed at the upstream boundary of the site to create an additional new pool in Reach 6, as well as anchor the tree toe-slope treatments. This pool will provide additional velocity shelter and refugia for trout migrating upstream through the crossing during spawning. The road approaches to the low water crossing will be hardened using large gravel and cobble imported to the site. The gravel/cobble armoring of the approaches will extend down to the ordinary high water mark of the channel, but not below this elevation. Additionally, water-bars will be constructed on the southern approach to the crossing in order to deflect run-off from the road away from the creek. Benefits of this work will include eliminating the hydrologic connection between the road and the stream, eliminating a potential barrier to migration, and providing the ranch with a

potential hardened watering site for cattle when the pasture is grazed., Seven pieces of large wood, and 30 - 32 boulders (0.5 yd³ each) and approximately 22 yd³ of cobble will be required for this site. Fill below the ordinary high water mark of the stream for each cross-vane is estimated to be approximately 8 yd³. Bank stabilization fill below the ordinary high water mark is expected to be approximately 0.1 yd³ per linear foot of bank for the log-toe-slope structure. Additionally, up to 7 yd³ of transplanted willow and sedge mats may be used to re-vegetate the areas behind the log toe-slope structures. Total fill, including boulder, willow/sedge transplants and large wood for the site is estimated not to exceed 43 yd³.

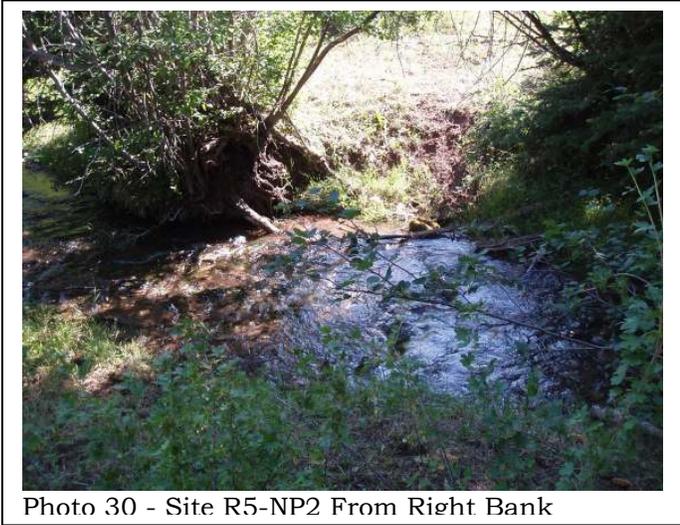
Photo 30 - Site R5-NP2 From Right Bank

Site R5-NP2 (Photo 30) is 26 ft. upstream of the previous new pool site, and corresponds with Glide 2 in the BWSHI. This habitat is well suited for conversion to a plunge pool by installing a double-log cross-vane at the upstream boundary of the feature to enhance scour. Two pieces of large wood, and 5- 6 boulders (0.5 yd³ each) will be required for this site. Fill below the ordinary high water mark of the stream for the log/boulder vane is estimated to be approximately 5 yd³.

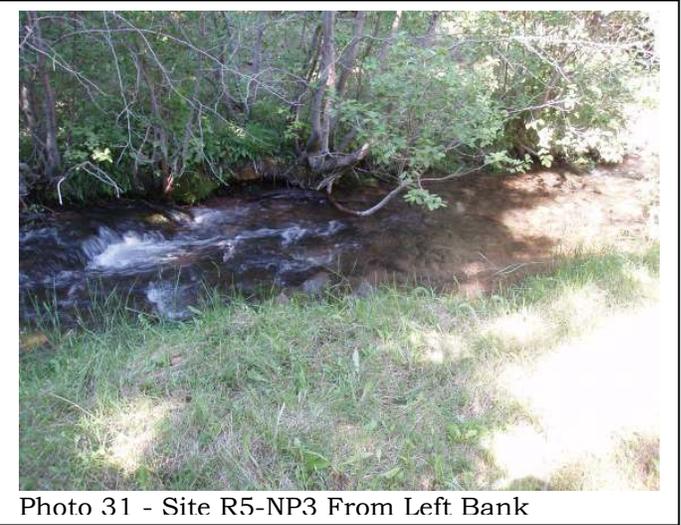
Photo 31 - Site R5-NP3 From Left Bank

Site R5-NP3 (Photo 31) corresponds with Pool 18 in the BWSHI, and Cross-Section #5 discussed in the previous chapter. This habitat is characterized by a well armored substrate, allowing little scour and poor residual pool depth in the feature. Larger cobbles/boulder armoring the channel within the pool will be removed to enhance scour. Large cobble and boulders removed from the pool and existing boulders immediately upstream of the pool will be re-configured as a cross-vane to enhance scour through the habitat. Any excess materials will be removed from the site and placed outside the water influence zone of the stream.

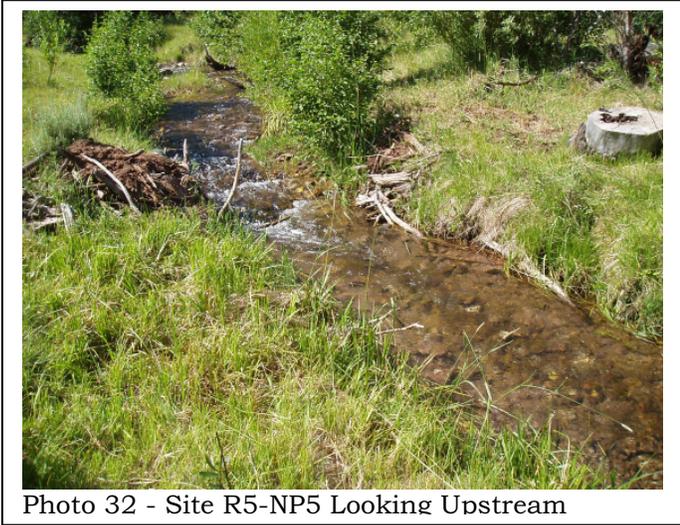
Photo 32 - Site R5-NP5 Looking Upstream

Site R5-NP5 (Photo 32) corresponds with Glide 6 in the BWSHI. There is a remnant of a beaver dam near this feature. This habitat is a natural low-gradient transition between two cobble riffles, and is well suited for conversion to a plunge pool by installing a double-log cross-vane at site of the beaver dam remnant. Two pieces of large wood, and 5- 6 boulders (0.5 yd³ each) will be required for this site. Fill below the ordinary high water mark of the stream for the log/boulder vane is estimated to be approximately 5 yd³.

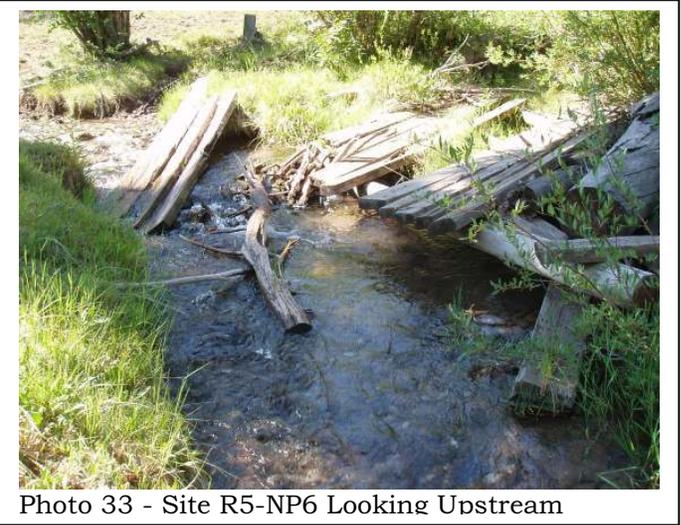
Photo 33 - Site R5-NP6 Looking Upstream

Site R5-NP5 (Photo 33) corresponds with Pool 31 in the BWSHI. There is a collapsed bridge fragment along the right bank of this feature that is providing some overhead cover. The pool itself is poorly functioning, exhibiting limited residual pool depth and cover. This habitat may be enhanced by removing larger cobbles/boulder armoring the channel within the pool and re-configuring

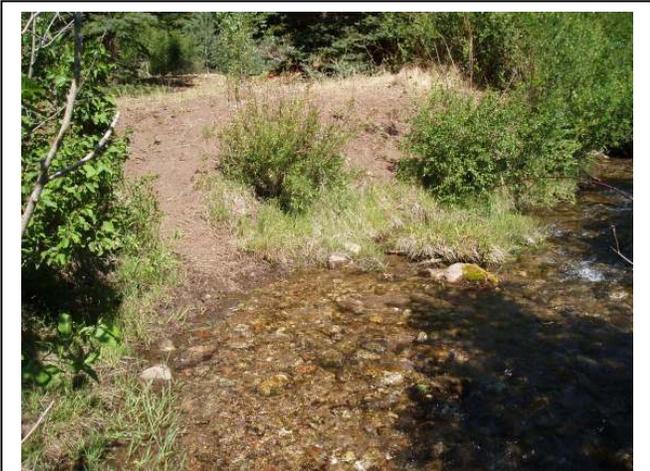
Photo 34 - Site R6-EB2 Left Bank

and Rattlesnake Creek (Photo 34). The site consists of 75 ft. of actively eroding stream bank on the right side of the channel, extending upstream past the confluence and up along the Beaver Pond outflow channel. The channel is over-wide throughout the upstream half of this site, due to the collapsing banks. There is good access to the site from the road immediately to the west. The collapsing right bank will be stabilized using three log toe-slope bank structures. The downstream log will be placed flush against the bank since W/D ratios are not an issue along this portion of the channel. The other two log toe-slope structures will be installed so as to reduce the width/depth ratio of the channel to a W/D of 10-11. Additionally, a cross vane will be installed at the downstream boundary of the site to enhance an existing pool, as well as anchor the tree toe-slope treatments. Three pieces of large wood, and 12 - 14 boulders (0.5 yd³ each) will be required for this site. Fill below the ordinary high water mark of the stream for the cross-vane is estimated to be approximately 6 yd³. Bank stabilization fill below the ordinary high water mark is expected to be approximately 0.1 - 0.25 yd³ per linear foot of bank for the log-toe-slope structure, depending on whether the structure is used to reduce W/D ratios in addition to bank stabilization and revegetation. Total fill for the site is estimated not to exceed 21 yd³.

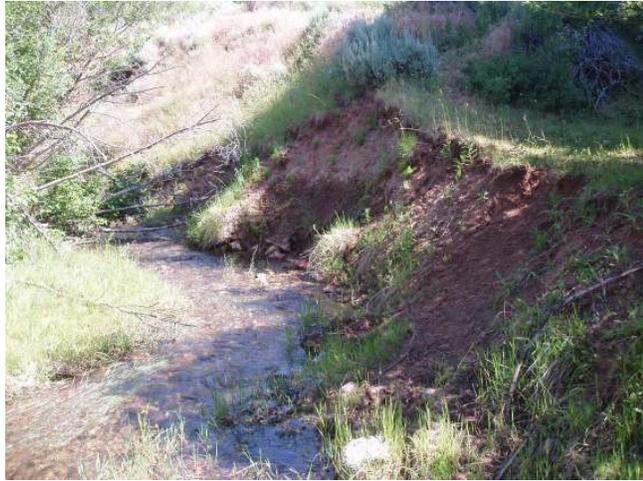
Photo 35 - Site R6-EB4 Looking Downstream

Site R6-EB4 (Photos 35) consists of 60 ft of actively eroding stream bank on the left side of the stream channel. Care will need to be taken to access this site, as it is the farthest site from the road that has been identified for treatment. A path that crosses no wet areas or important riparian/water influence zones has been identified that begins upstream of the off channel beaver pond and follow a bench above the right bank of the stream downstream to the site. Minimal existing vegetation (one or two small alder/aspens saplings) will need to be removed to use this path. Three toe-slope structures will be installed, placing the trees flush along the left stream bank, and revegetating the bank with willow and sedge harvested from the point bar beyond the right bank of the stream. Three pieces of large wood, available at the site, and 4 boulders (0.5 yd³ each) will be required for this site. Bank stabilization fill below the ordinary high water mark is expected to be approximately 0.1 yd³ per linear foot of bank for the log-toe-slope structure. Total fill for the site is estimated not to exceed 6 yd³.

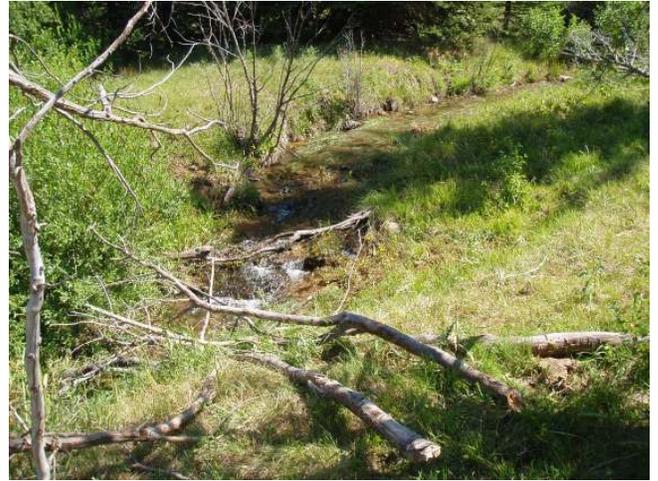
Photo 36 - Site R6-NP1 Looking Upstream

Site R6-NP1 is located approximately 325 ft upstream of R6-EB4, and can be accessed along the same route as that site (Photo 36). There is a natural constriction in the channel at this point where a large woody debris dam pool can be created by dropping two tree-tops into the channel. The trees will capture smaller woody debris moving through the stream and gradually form a dam pool. Suitable trees are available at the site. Total fill for the site is estimated not to exceed 3 yd³.

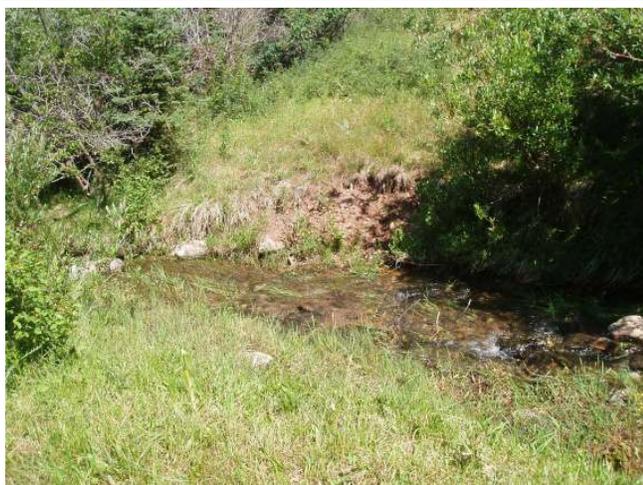
Photo 37 - Site R6-EB5 From the Right Bank

Site R6-EB5 (Photos 37) is approximately 80 ft upstream of R6-NP1, and consists of 20 ft of actively eroding stream bank on the left side of the stream channel. A single tree toe-slope structure will be installed, placing the tree flush along the left stream bank, and revegetating the bank with willow and sedge harvested from the point bar beyond the right bank of the stream. Additionally, there is a natural constriction in the channel immediately downstream of the site where a large woody debris dam pool can be created by dropping two tree-tops into the channel. Suitable trees are available at the site. Three pieces of large wood, and 2 boulders (0.5 yd³ each) will be required for this site. Bank stabilization fill below the ordinary high water mark is expected to be approximately 0.1 yd³ per linear foot of bank for the log-toe-slope structure. Total fill for the site is estimated not to exceed 5 yd³.

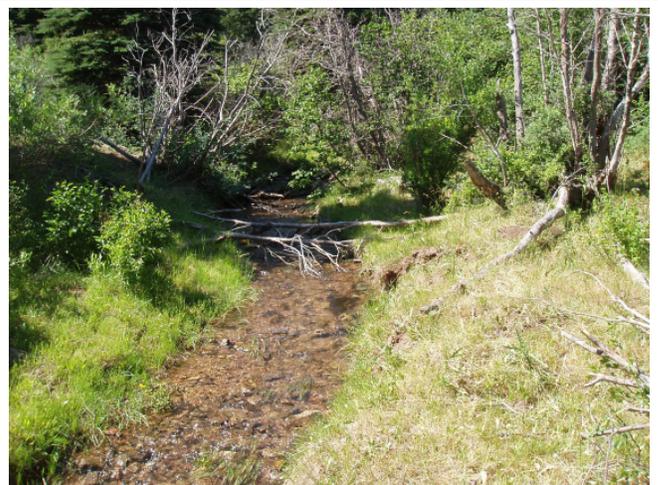
Photo 38 - Site R6-NP2 Looking Upstream

Site R6-NP2 is located approximately 165 ft upstream of R6-EB5, and can be accessed along the same route as that site (Photo 38). The site is characterized by a brief low-gradient transition within a long high gradient boulder/cobble riffle. A new plunge pool will be constructed at this site by installing a boulder cross vane in the channel. Eight to ten boulders (0.5 yd³ each) will be required for the cross-vane. Total fill for the site is estimated not to exceed 5 yd³.

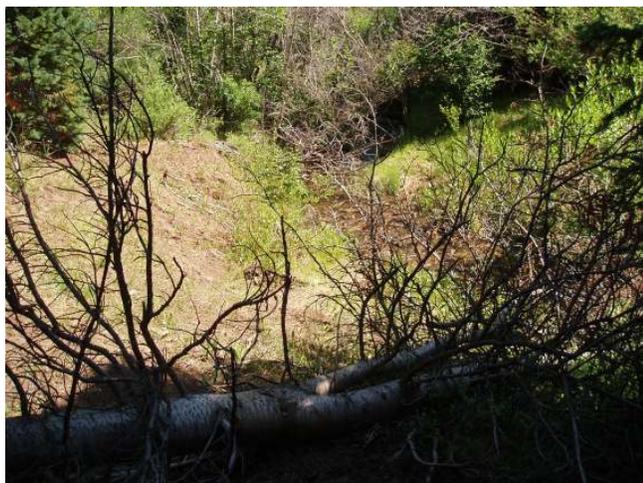
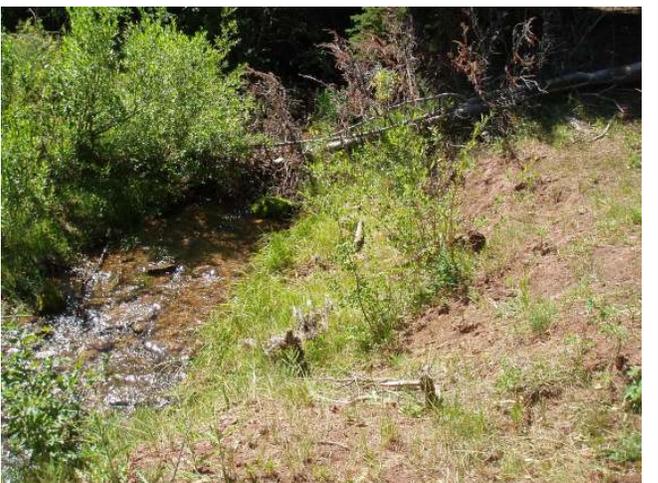
Site R6-EB6 (Photos 39 & 40) is 80 ft upstream of R6-NP2, and consists of 20 ft of generally unstable stream bank on the right side of the channel. Treatment

will include installing a tree flush along the right stream bank, and revegetating the bank with willow and sedge harvested from near the site. A small log/boulder vane will be installed at the upstream boundary of the toe slope structure to enhance scour and cover in an existing pool. Two pieces of large wood, and 4 - 5 boulders (0.5 yd³ each) will be required for this site. Fill below the ordinary high water mark of the stream for the log/boulder vane is estimated to be approximately 2.5 to 3.5 yd³. Bank stabilization fill below the ordinary high water mark is expected to be approximately 0.1 yd³ per linear foot of bank for the log-toe-slope structure. Total fill for the site is estimated not to exceed 5.5 yd³.

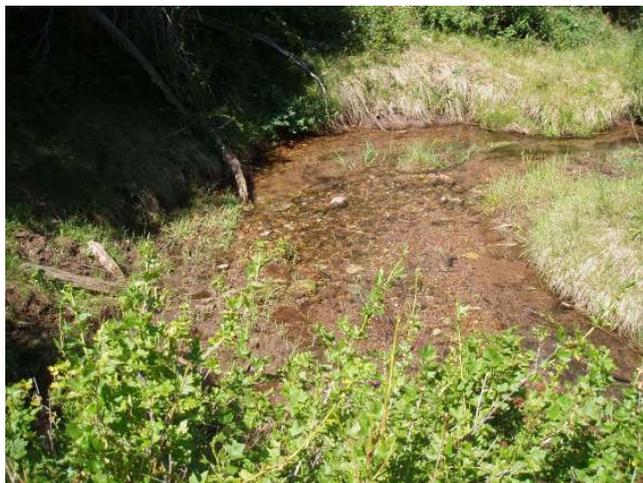
Photo 41 - Site R6-EB7 Looking Downstream

The remaining sites on Rattlesnake Creek Reach 6 may be easily accessed from the forest opening noted as ACCESS1 on the map, upstream of the off-channel beaver pond. Site R6-EB7 (Photo 41) is 200 ft upstream of R6-EB6, and appears to be a cattle watering and crossing area. The site is generally over-wide, with 40 ft of unstable stream bank on the right side of the channel. Treatment will include installing two logs along the right stream bank, and revegetating the bank with willow and sedge harvested from near the site. Accumulated sediments from the existing scour pool immediately downstream will be excavated and removed from the site and placed outside the water influence zone of the stream. Two pieces of large wood, and 3-4 boulders (0.5 yd³ each) will be required for this site. Bank stabilization fill below the ordinary high water mark is expected to be approximately 0.2 yd³ per linear foot of bank for the log-toe-slope structures. Total fill for the site is estimated not to exceed 8 yd³.

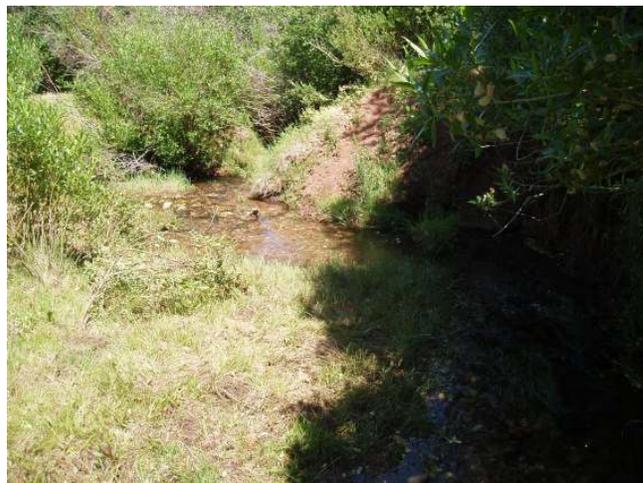
Photo 42 - Site R6-EB8 Looking Downstream

Site R6-EB8 (Photo 42) is 135 ft upstream of R6-EB7, and appears to be another cattle watering and crossing area. The site is also somewhat over-wide, with 20 ft of unstable stream bank on the left side of the channel. Treatment will include installing a log toe-slope structure along the left stream bank, and revegetating the bank with willow and sedge harvested from near the site. A small log/boulder vane will be installed at the downstream boundary of the toe slope structure to enhance scour and cover in an existing pool. Accumulated sediments from the existing pool will be excavated and removed from the site and placed outside the water influence zone of the stream. Two pieces of large wood, and 3-4 boulders (0.5 yd³ each) will be required for this site. Bank stabilization fill below the ordinary high water mark is expected to be approximately 0.2 yd³ per linear foot of bank for the log-toe-slope structures. Total fill for the site is estimated not to exceed 6 yd³.

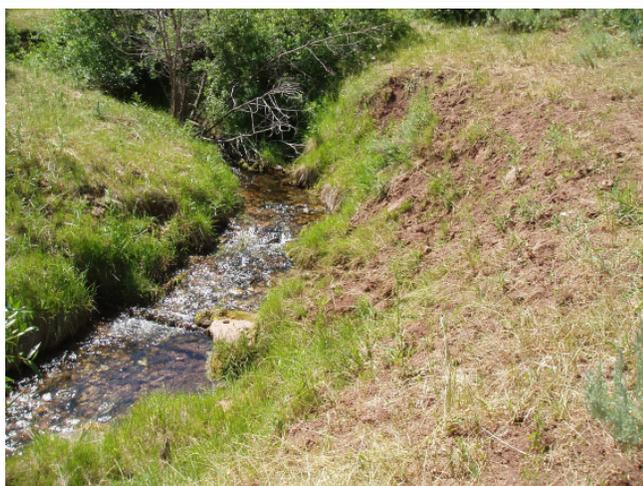
Photo 43 - Site R6-EB9 Looking Upstream

Site R6-EB9 (Photo 43) is 135 ft upstream of R6-EB8, and appears to be yet another cattle watering area. The site appears to be healing on it's own, with riparian sedge becoming established along the toe slope of the unstable right bank. This bank should continue to be monitored to ensure that it continues an upward trend.

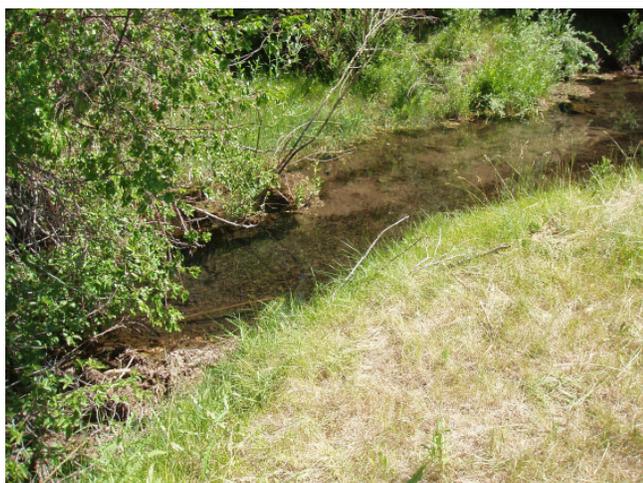
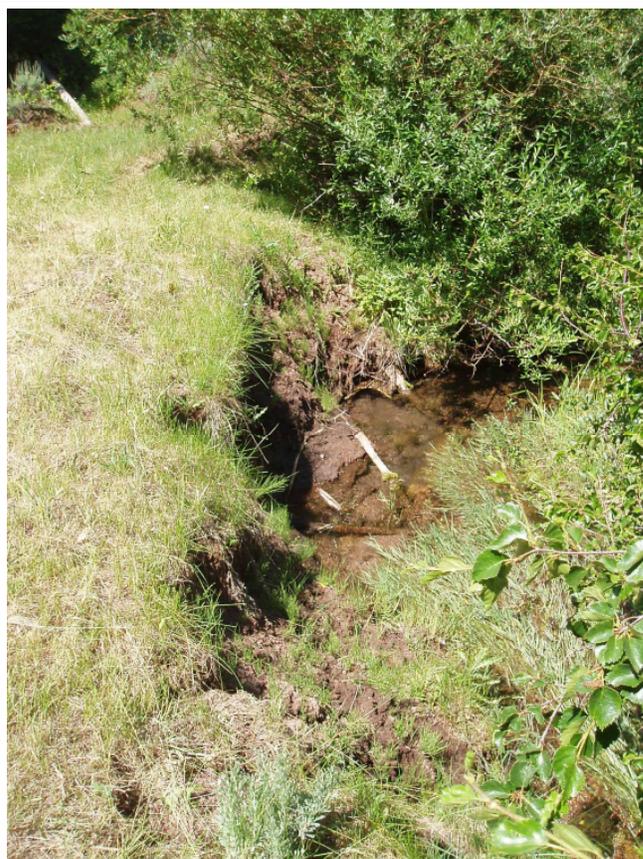
Site R6-EB10 and R6-HC1 are 75 ft and 120 ft upstream of R6-EB9, and are combined into one treatment site, due to the influence that R6-HC1 has on the eroding banks of R6-EB10. Site R6-EB10 consists of approximately 20 ft of unstable eroding right bank (Photo 44) on the outside bend a meander bend,

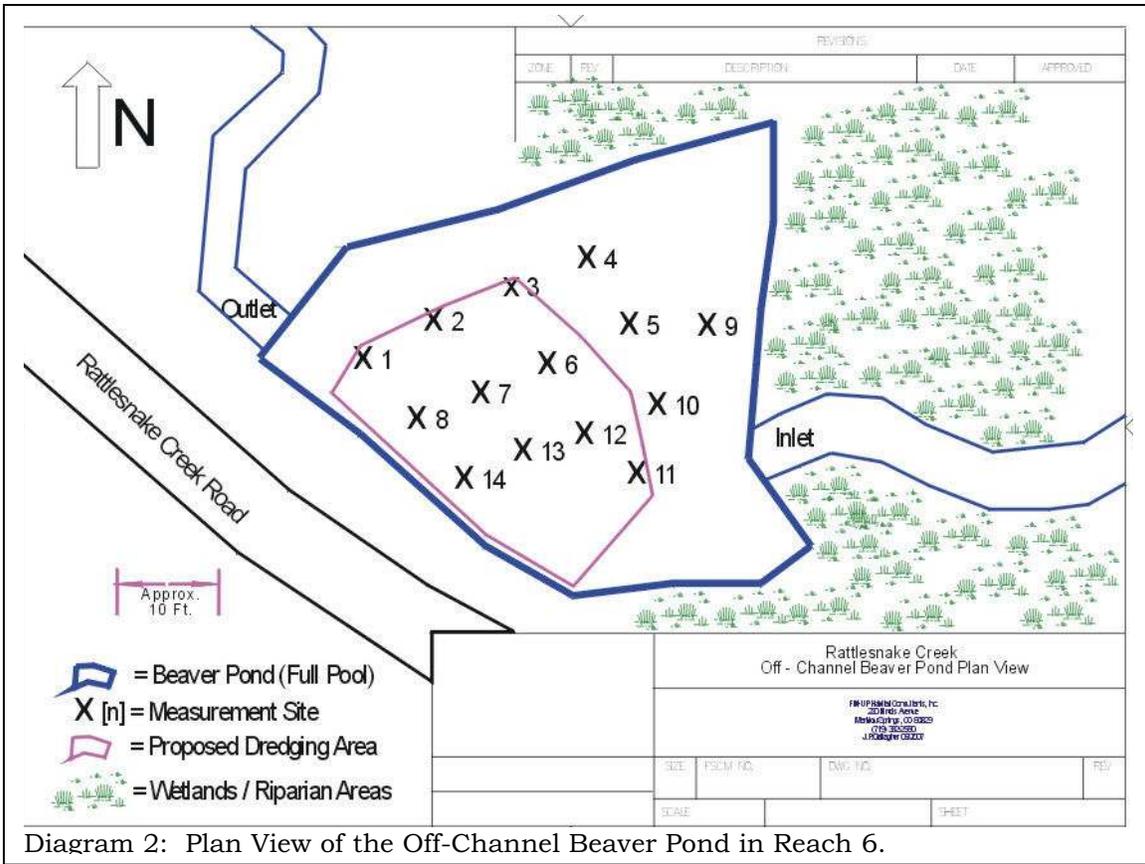
Diagram 2: Plan View of the Off-Channel Beaver Pond in Reach 6.

A sediment deposition depth profile, using a graduated wading staff, indicates that 1 to 3 feet of depositional sediment and detritus may be excavated from the western half of the pond (Diagram 2). It is expected that approximately 300 - 325 yd³ of material will be dredged from the pond and removed from the site. Average depth of the pond will be increased from 1.8 ft at full-pool stage to 2.6 ft. The maximum depth of the pond will not change, but the area of maximum

depth will increase by approximately 20%. While the surface acreage of the pond will remain the same, the volume of the pond will increase to 0.7 acre/ft.

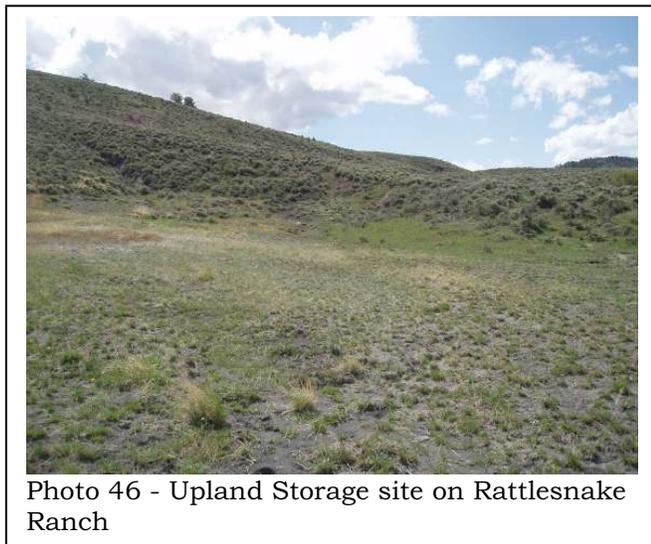
Photo 46 - Upland Storage site on Rattlesnake Ranch

The preferred method for accomplishing this dredging is to use a long-reach excavator (72 ft boom) to dredge the lake from the Rattlesnake Creek Road, hauling the dredged spoils 1.5 miles downstream to an identified upland storage site on the Rattlesnake Ranch (Photo 46). This type of excavator will provide approximately a 45 ft reach into the pond. If this method is used, the work can be accomplished in a non-jurisdictional manner, and will require no temporary fills or crossing of riparian or wetland areas.

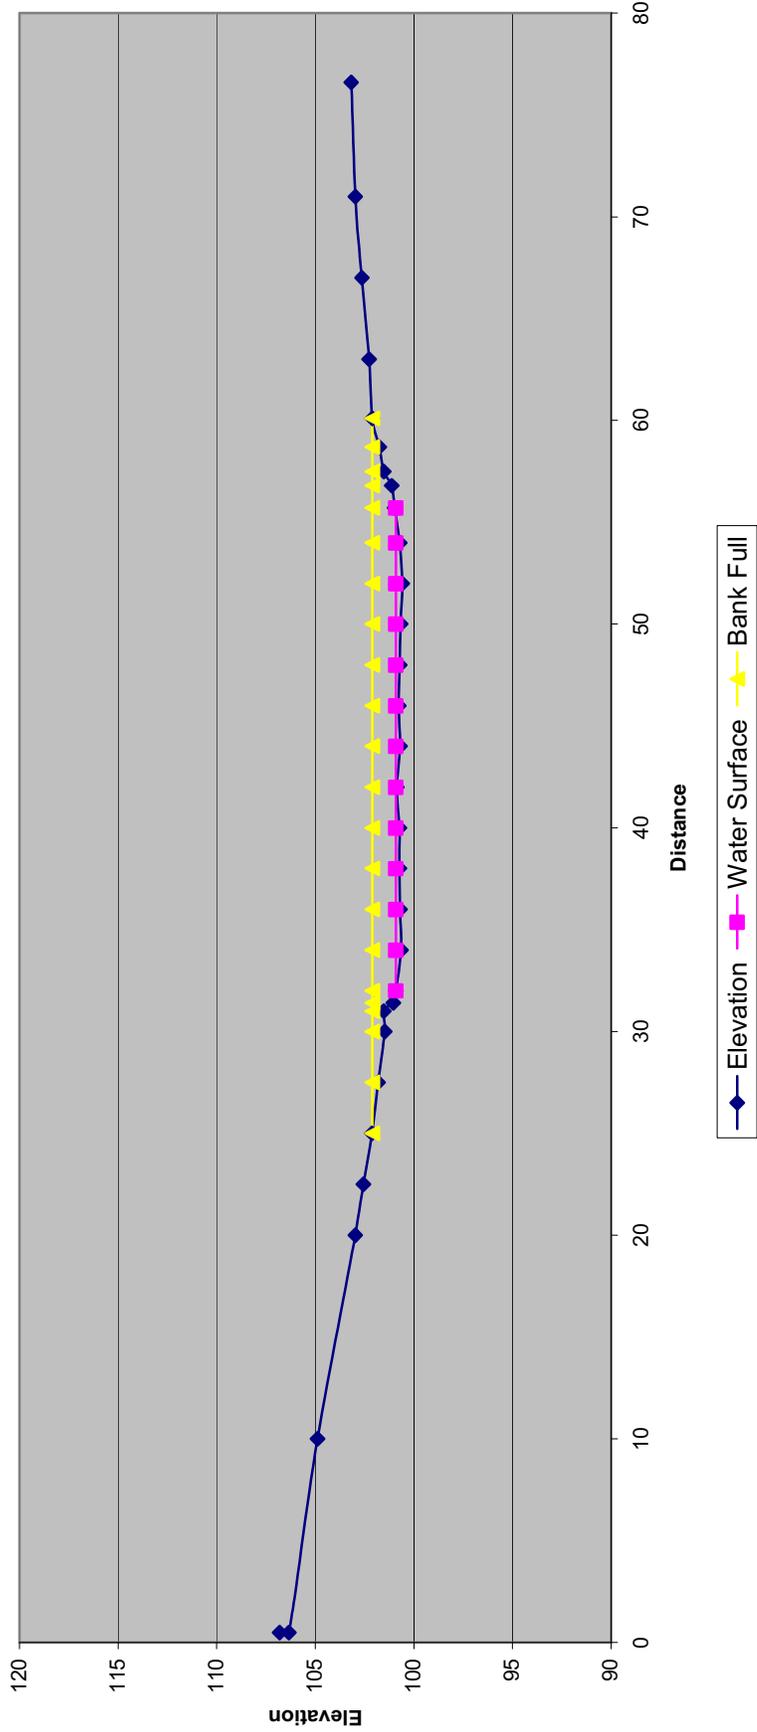
Rattlesnake Creek X-Section #1 At the Road Crossing at Reach5 / Reach 6

Additionally, there are several segments of the reach that exhibit channel width/depth ratios greater than would be expected or desirable in this channel type. Over-wide channels are a significant problem at the Reach 5/Reach 6 road crossing, and immediately downstream of this point (Cross-Section #3, Chart 9), where width/depth ratios range from 13 to over 31. The road crossing (Cross-Section #1, Chart 8) is likely a barrier to fish migration through the reach during the low flows found in late summer and fall, due to lack of depth or defined channel through the crossing. The photographs in each of these charts are taken from downstream of the cross-sections, looking upstream.

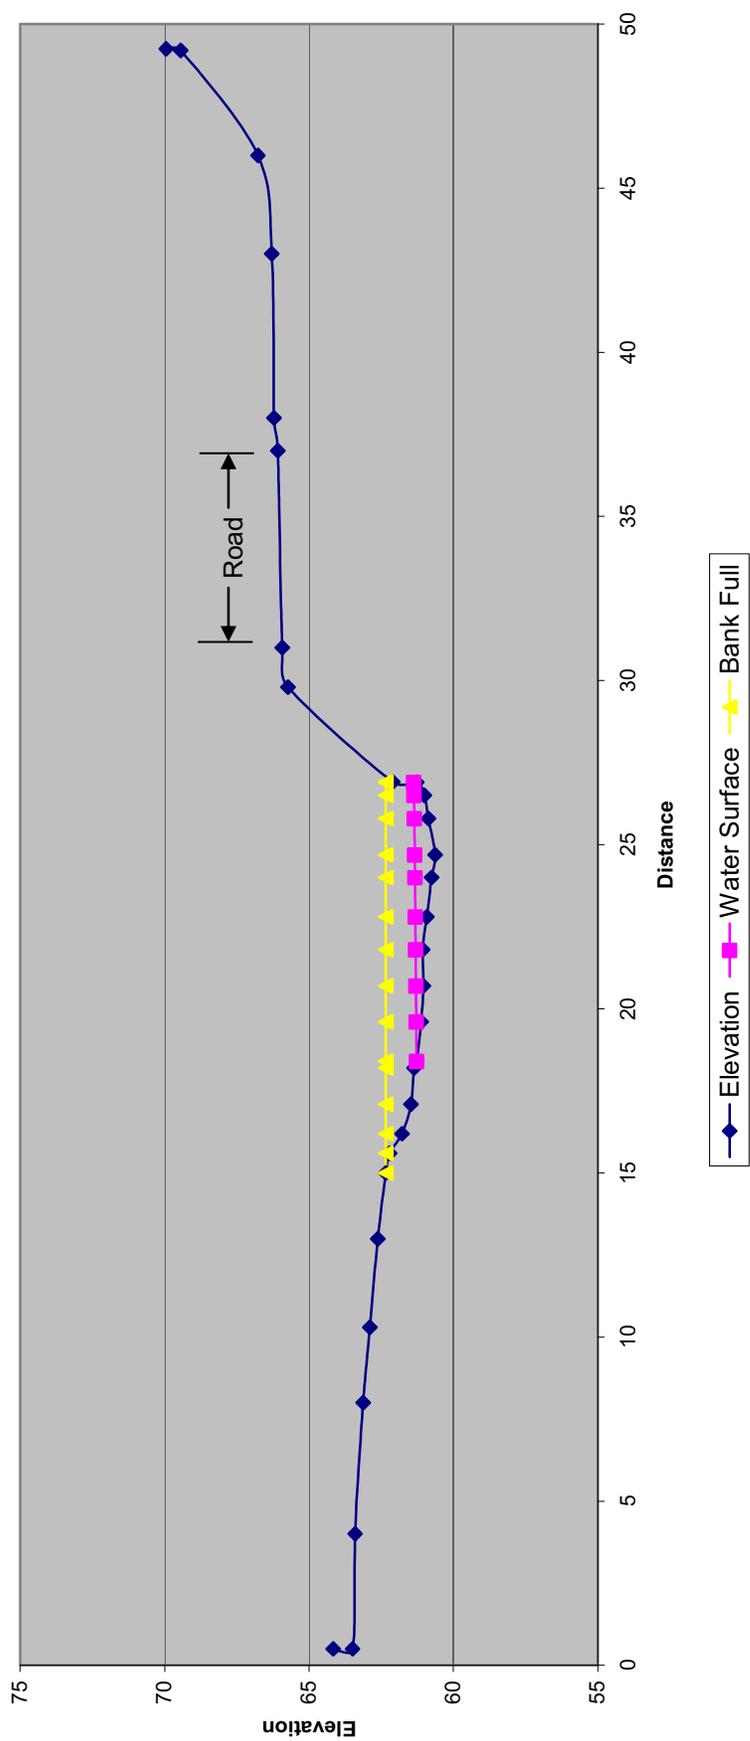
**Rattlesnake Creek X-Section #6
At Eroding Bank #1 / Riffle #7
Immediately Adjacent to the Road**

Cross-Section #6 is an example of the road/stream interactions occurring within the reach (Chart 7). As is the case with Cross-Section #4, the stream exhibits an extremely tight meander bend at the point where it is immediately adjacent to the road. The road-side stream bank vegetation is shallow rooted and very sparse, and the bank has failed at several points. Left untreated, the stream will eventually erode the bank to the point where the road will be cut-off. The photo in Chart 7 shows the cross-section from upstream of the site, looking downstream.
