Aquatic Assessment
&
Habitat Enhancement Plan
Fountain Creek and Shryver Pond
Shryver Park
City of Manitou Springs
El Paso County - Colorado

FIN-UP Habitat Consultants, Inc.

J. Peter Gallagher
220 Illinois Ave
Manitou Springs, CO 80829
(719) 685-9768 (Office)
(719) 332-2550 (Cell)
pete@fin-up.com
June 1, 2008

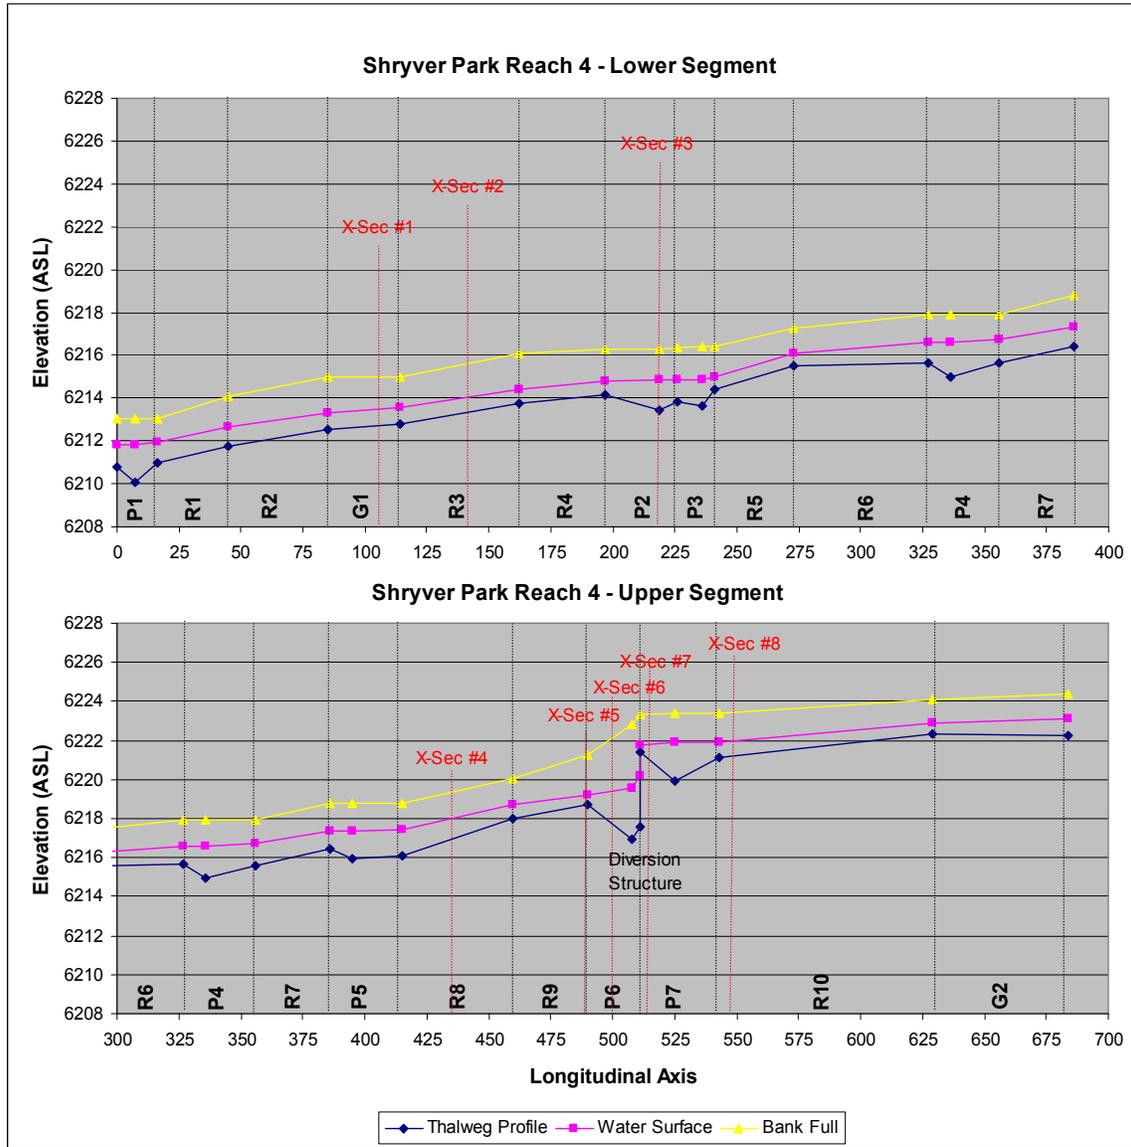
Chart 1: Longitudinal Profile of Reach 4 on Fountain Creek.

A longitudinal profile (Chart 1) of the stream channel and the two cross-sections were established in May 2008. Stream flow was measured at cross-section #2, using a Marsh-McBirney FlowMate 2000 flow meter, and was calculated to be 8.5 cfs. The longitudinal profile is typical of Fountain Creek through the City of Manitou Springs, characterized by relatively low gradient, a moderate to high degrees of entrenchment, and infrequent pool habitat. The average slope of the channel, water surface and bank full elevation

throughout the profile was 2%. Riffle slopes ranged from 2% to 5%. Stream channel sinuosity was low (<1.5) in the reach, as would be expected for a B type channel.

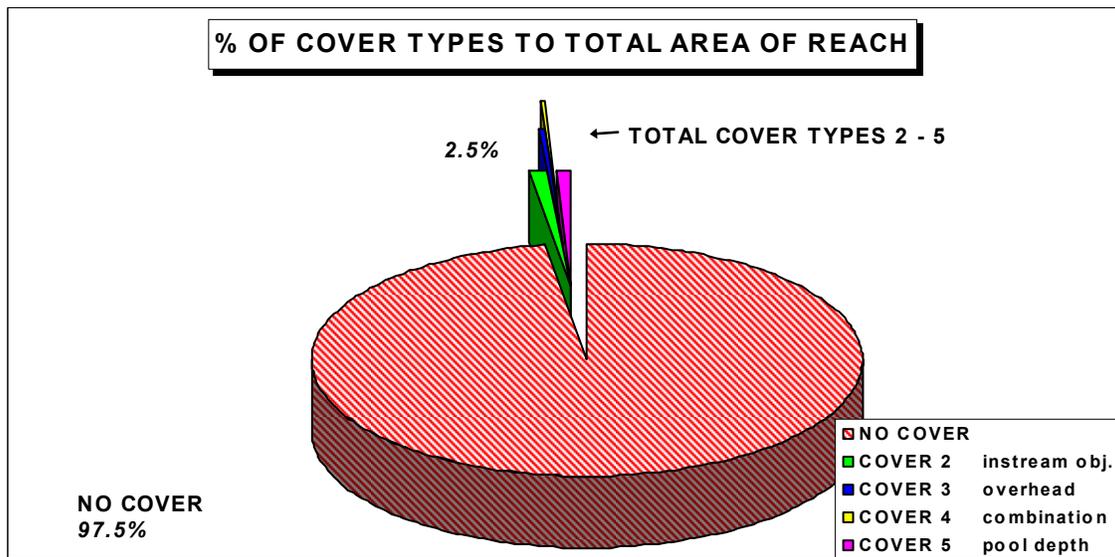
Chart 8 - Percentage of cover for trout to the total wetted perimeter Reach 4 on Fountain Creek.

Cover for adult trout accounted for 2.5% of the reach (Chart 8). Available cover appears to be a limiting factor to the health of the fishery, and will be addressed in the Habitat Enhancement Plan. Instream object cover (Cover Type 2 - >1' deep) was the dominant type observed in the reach, and was typically associated with the pool habitats. Pool cover (Cover Type 5 - >1.5'deep) was somewhat limited in the reach, and comprised only 3.4% of the wetted area of the pools and 0.9% of the total reach area. Pool cover is an important indicator for determining the available over-wintering capacity of the stream reach, and appeared to be severely limited in this reach. Combination and overhead cover were the least abundant cover types, due to the lack of streamside vegetation and poor stability of the stream banks. Instream cover could be enhanced in the riffle habitats by adding structure and velocity shelters along the stream banks with strategically placed boulders and large wood. Pool cover may be increased by improving scour in existing pools as well as creating new pool habitats. Overhead and combination cover may be improved throughout the reach through stabilizing and revegetating the eroding stream banks.

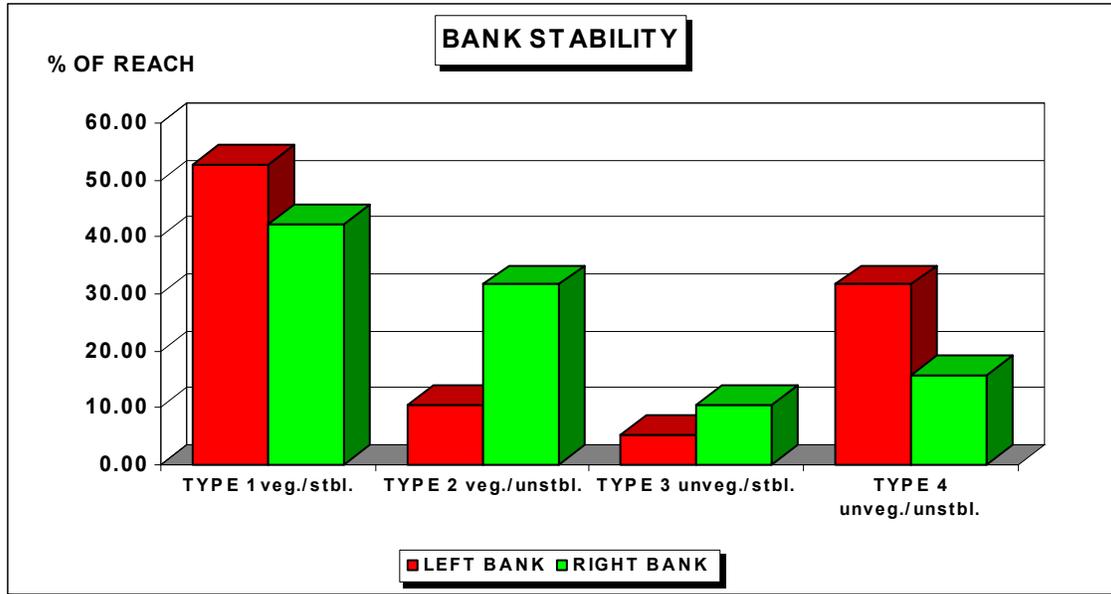
Stream bank stability was generally poor in the reach, primarily due to lack of vegetation on the steep collapsing stream banks. Several areas of actively eroding stream banks were observed, particularly in the upstream half of the reach. Deeply rooted, streamside riparian vegetation is a critical component in maintaining the integrity of stream banks during runoff and other high flow events, and was generally lacking in this reach. Fifty-three percent of the left bank and 42% of the right bank were found to be vegetated and stable. 5% of the left bank and 11% of the right banks were observed to be stable due to concrete toe walls that have been installed along the stream bank. The remaining 42% of the left bank and 47% of the right bank were found to be unstable. (Chart 9). Bank rock content in the reach is shown in Chart 10, and consisted either of concrete (Type 2), large boulder (Type 3) or gravel and smaller fragments (Type 6 and 8). Smaller fragments were the most dominant type, indicating that the stream banks are susceptible to erosion due to sheer forces occurring during high flows.

Chart 9 - Percentage of stable banks to unstable banks in Reach 4 on Fountain Creek.

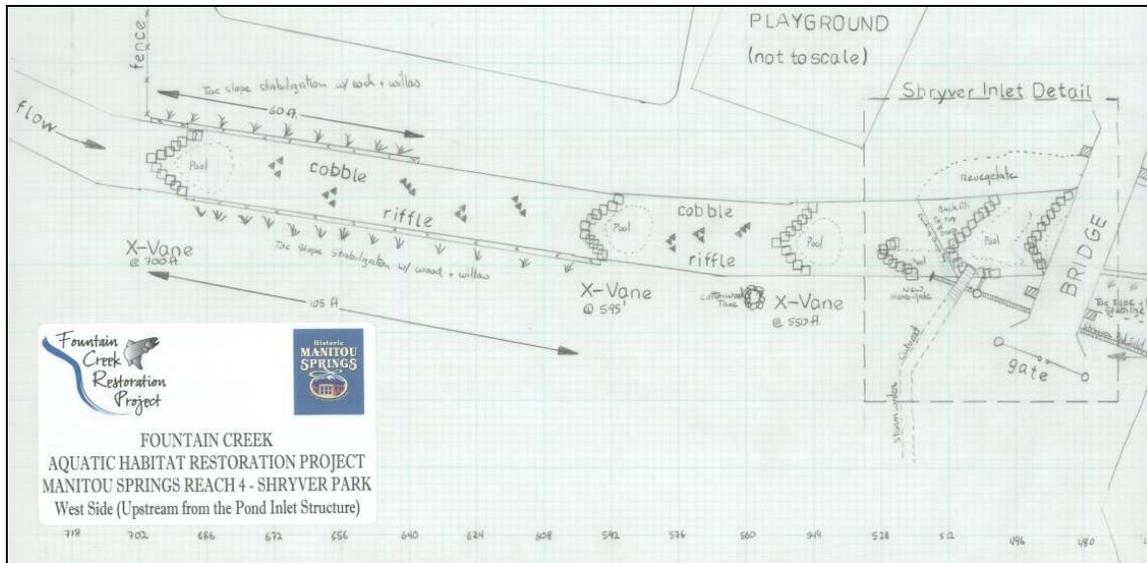
Plan view of habitat enhancements and bank stabilization in the upstream 1/3 segment of Reach 4, including the new Shryver Pond Inlet Works.

The treatments in the area around the diversion/Shryver Pond inlet structure have already been described in the previous section. Upstream of the diversion structure, three more cross-vanes will be installed to create new pool habitat, as well as enhance existing features in the stream. Stream banks are in exceptionally poor condition in this segment, requiring 165 feet of stream bank toe-slope and bank full benching treatments be installed to stabilize these features. Pocket water habitat is very limited in the riffles within this segment, and will be greatly improved by the installation of at least 8 boulder associated micro-vortices. Detailed drawings of the habitat structures to be used in this project may be found in the Appendix. Bank-full and center structure elevations of the cross-vanes, bank full elevation of the stream bank benches, and 1/2 bank full elevations of the micro-vortex structures will be determined on an individual basis, using the longitudinal profile data collected in the pre-project assessment.

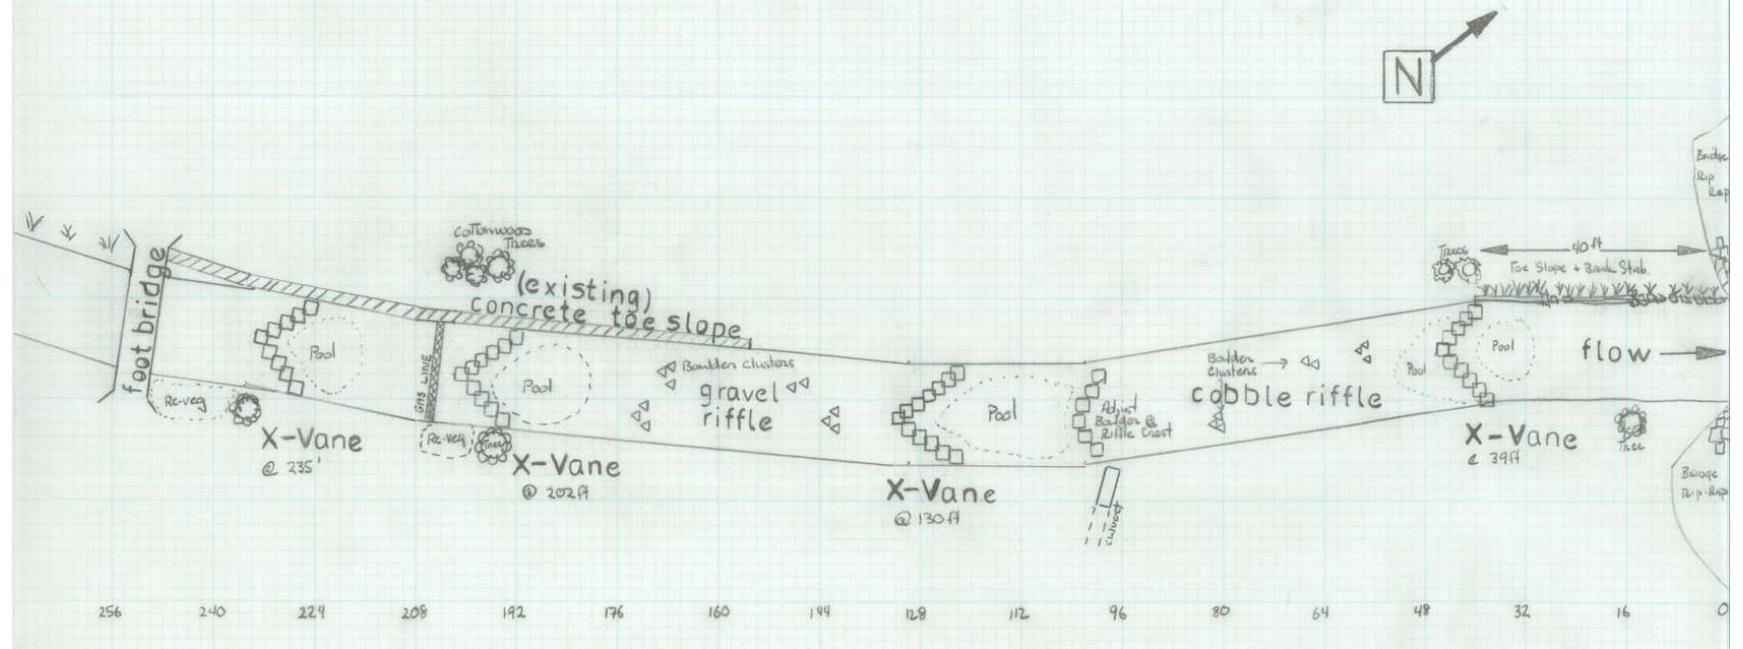
FOUNTAIN CREEK
AQUATIC HABITAT RESTORATION PROJECT
MANITOU SPRINGS REACH 4 - SHRYVER PARK
East Side (Downstream of the Foot Bridge)

Fountain Creek - Shryver Park Reach 4 Downstream Segment - Proposed Stream Restoration Treatments.

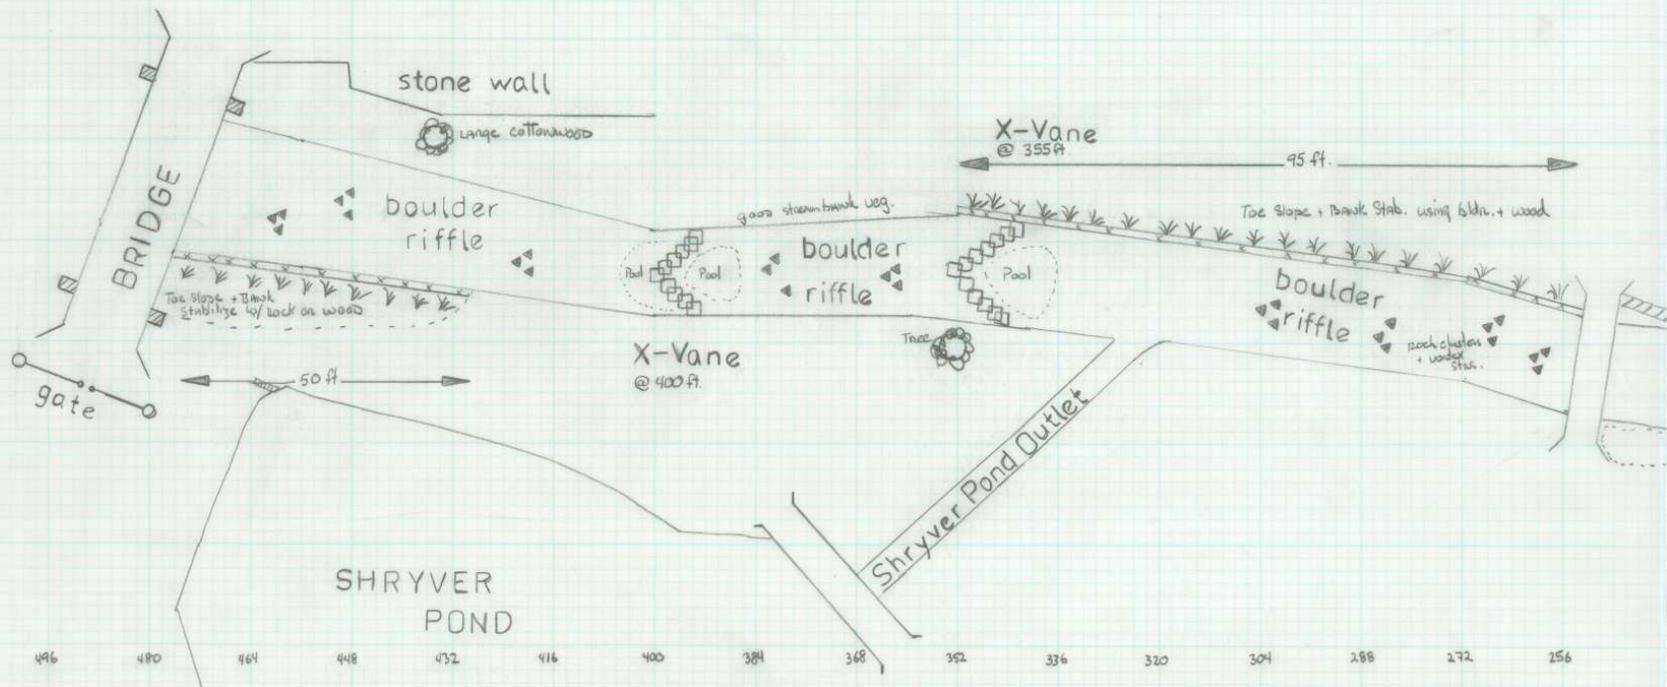
FOUNTAIN CREEK
 AQUATIC HABITAT RESTORATION PROJECT
 MANITOU SPRINGS REACH 4 - SHRYVER PARK
 Central Area (Foot Bridge to the Pond Inlet Structure)

Fountain Creek - Shryver Park Reach 4 Middle Segment - Proposed Stream Restoration Treatments.

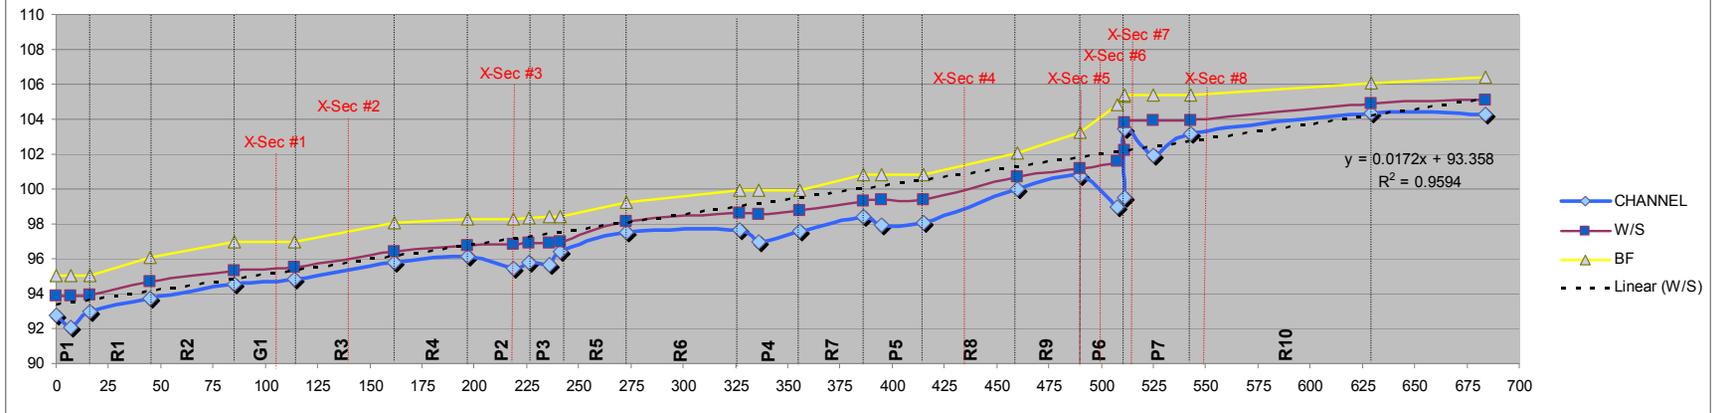
Fountain Creek Reach 4 - Longitudinal Profile

Longitudinal Profile of Fountain Creek Reach 4 - Shryver Park in Manitou Springs, CO.

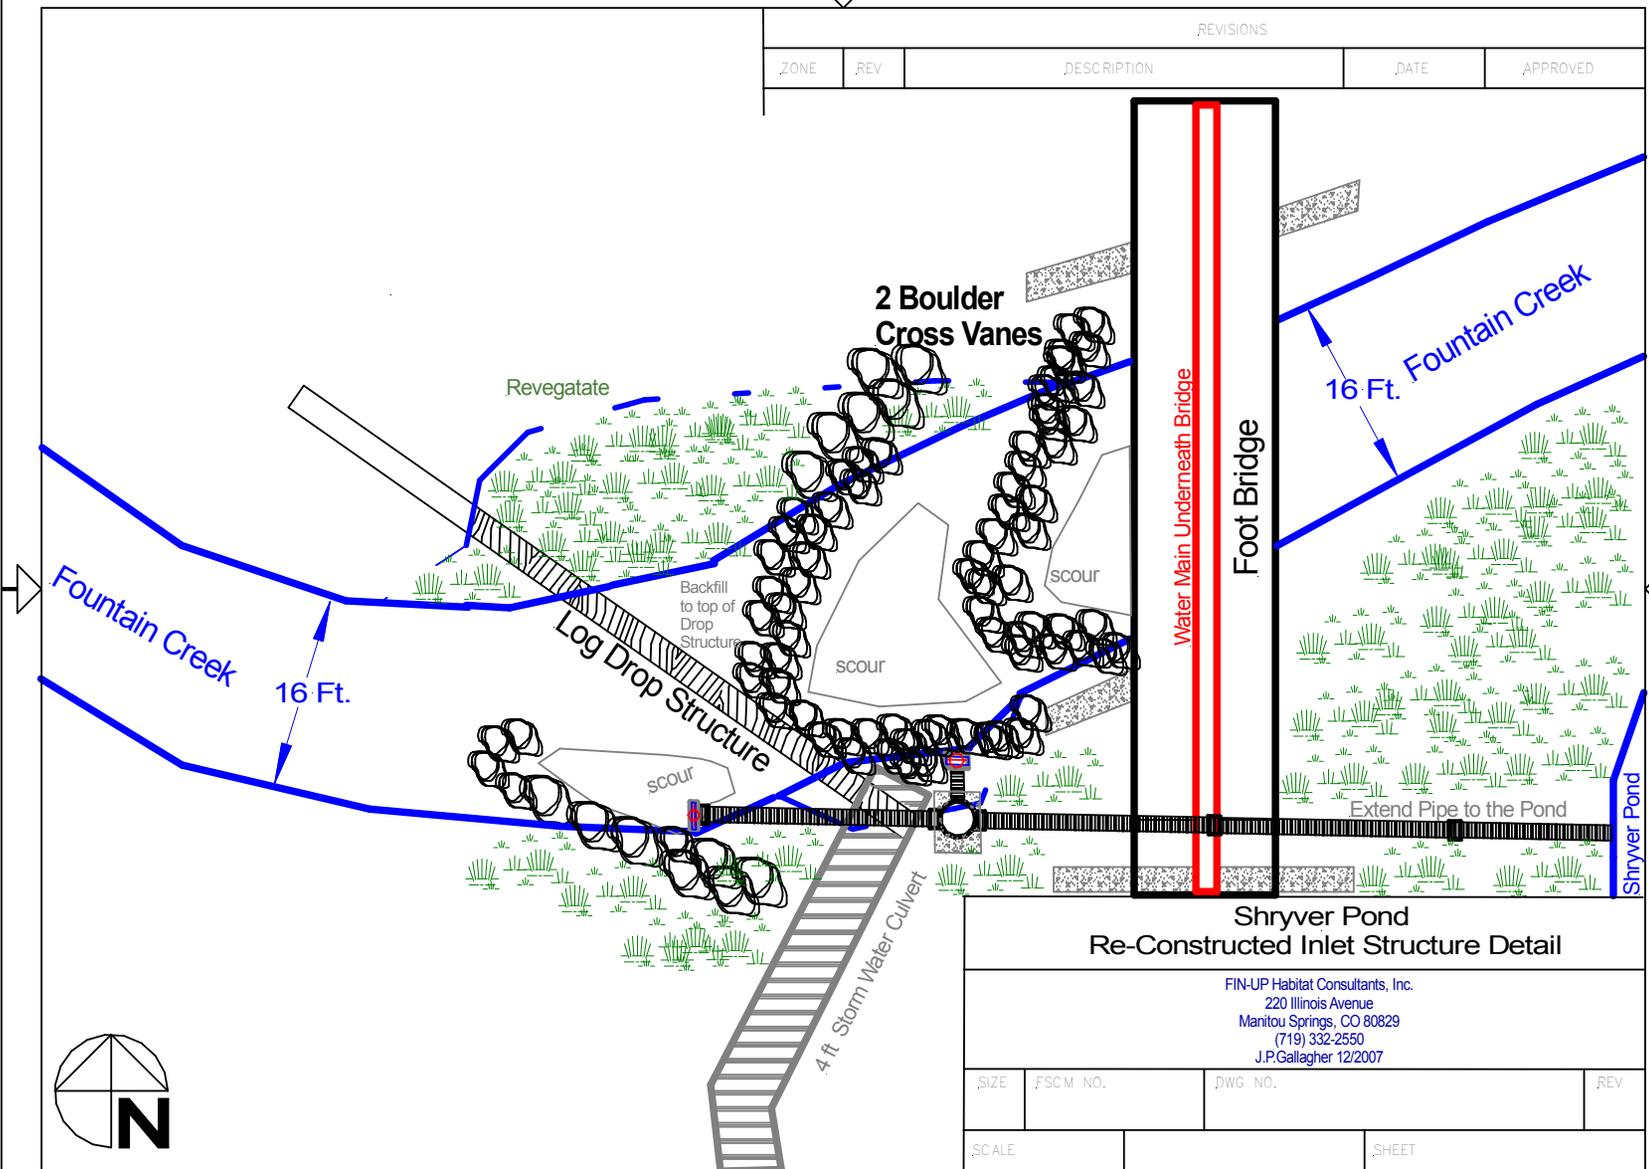
Shryver Pond Re-Constructed Inlet Structure Detail				
FIN-UP Habitat Consultants, Inc. 220 Illinois Avenue Manitou Springs, CO 80829 (719) 332-2550 J.P.Gallagher 12/2007				
SIZE	FSCM NO.	DWG. NO.	REV	
SCALE				SHEET

The first priority restoration effort includes reconstruction of the Shryver Pond Inlet works, including the elimination of the barrier to fish migration at the diversion point along Fountain Creek. The second priority will include bank stabilization and re-vegetation, as well as in-channel stream habitat enhancement within the remaining segments of Reach 4 in Shryver Park. The following section will address these priorities, and give specific recommendations and treatments to improve aquatic and riparian habitat conditions throughout the reach. A site plans showing the locations of the proposed enhancements can be found in the Appendix.

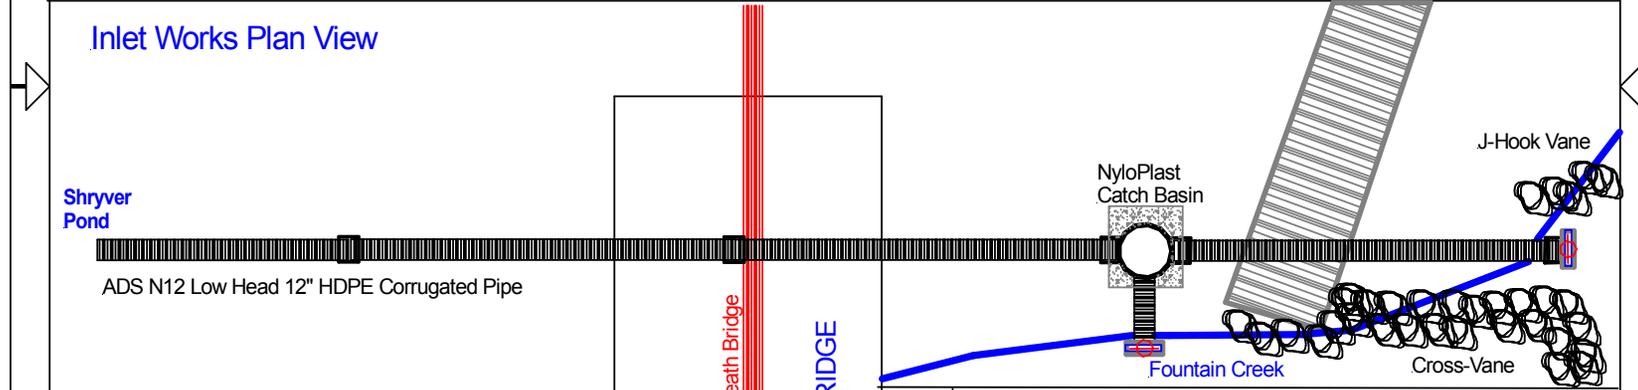
Inlet Works Plan View

Shryver Pond Inlet Structure Detail
